Report: 0007608

Confidential Inspection Report

1032 Whittier
Grosse Pointe, MI 48230

November 25, 2011

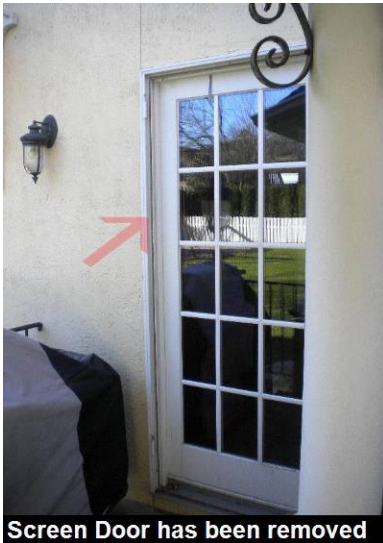
Screen Door has been removed

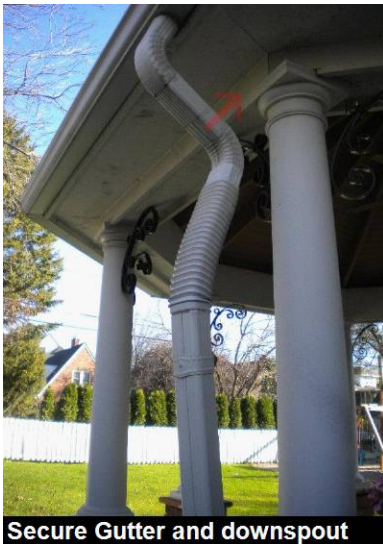
6. RR. Improper conditions viewed There should be a hard pipe installed here not flexible drainpipe.

Secure Gutter and downspout

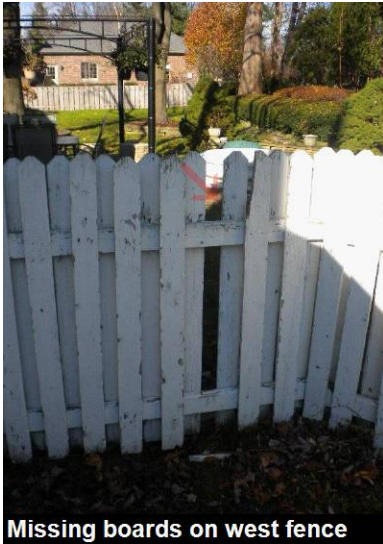
Missing boards on west fence

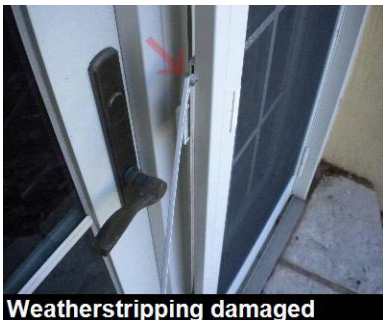
12. Metal, with glass. Screen door has damaged weatherstripping, RR.

Weatherstripping damaged

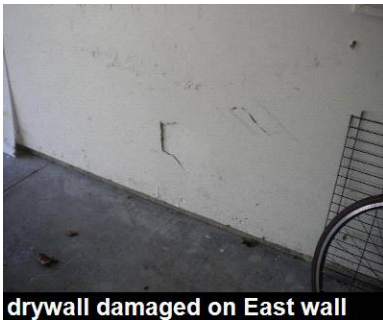
14. RR. Damage noted.

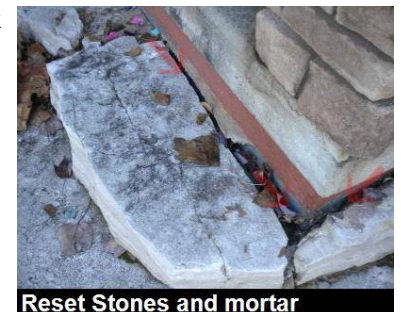
RR, Concrete with Stone work steps.

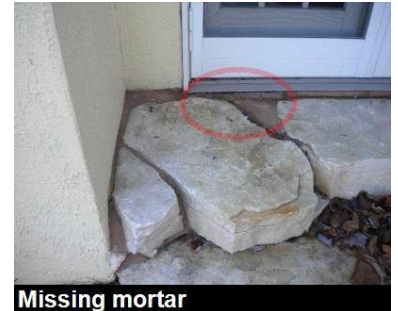
Missing mortar

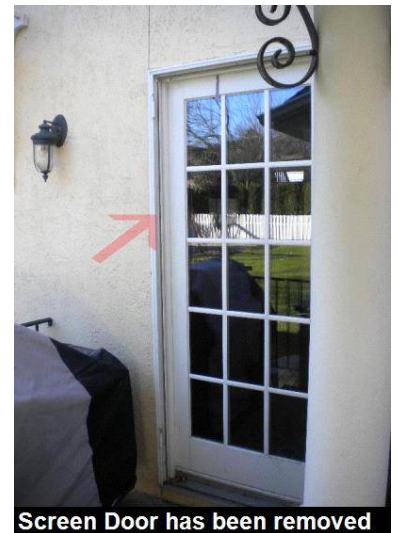
Screen Door has been removed

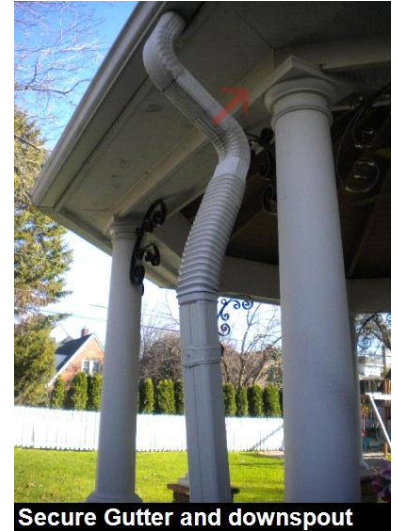
RR. Improper conditions viewed
There should be a hard pipe
installed here not flexible
drainpipe.

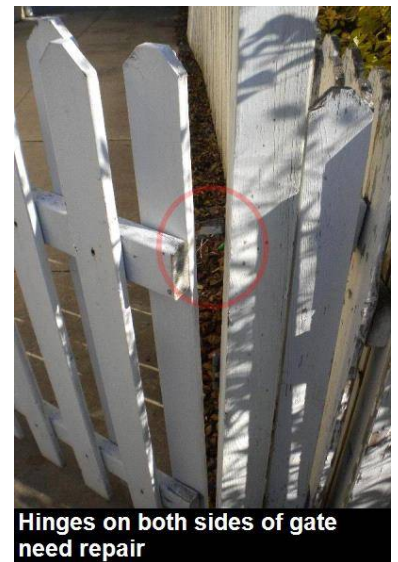
RR, Type: Wood, **Observations-**
Broken/missing boards.

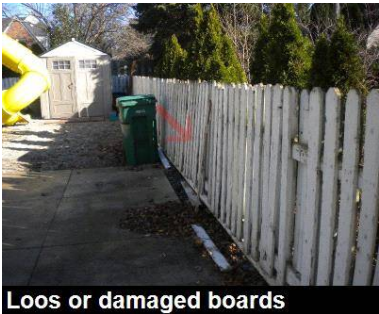
Loos or damaged boards

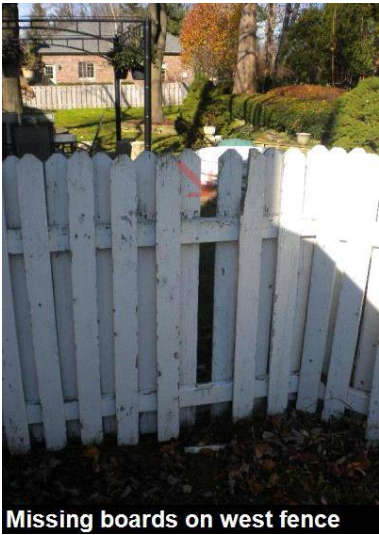
Missing boards on west fence

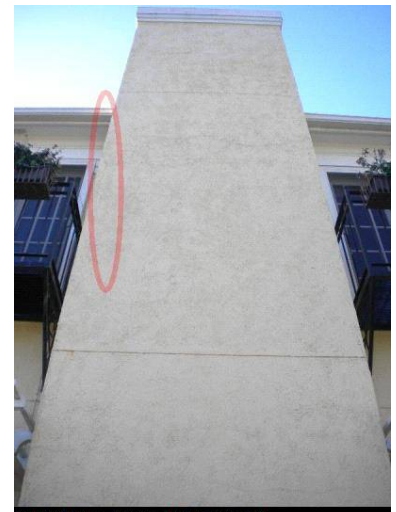
OK, Walls are constructed with Stucco. Cracks noted are typical, Small hairline cracks which are closed and without gaps can best be hidden by application of sealer prior to repainting. This can be done the next time the house needs repainting.

Hairline Crack Typical

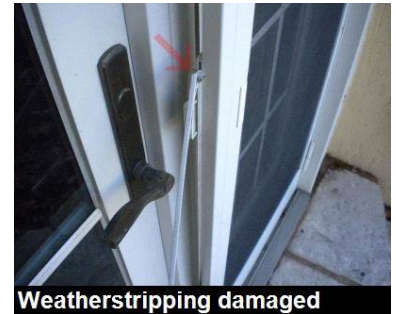
Metal, with glass. Screen door has damaged weatherstripping, RR.

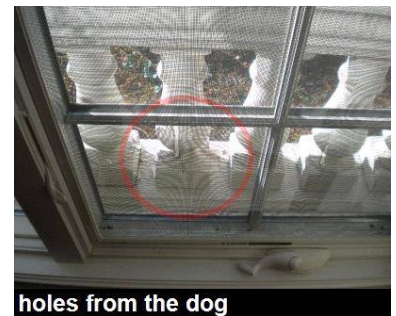
Satisfactory overall, considering age. Most screens are in good condition, with holes from the dog noted in the dining room.

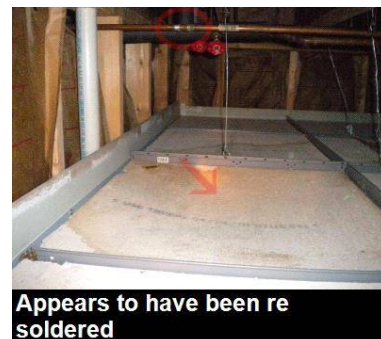
OK, No - There were no elevated moisture levels noted on the exposed areas of the basement walls. Staining was observed: in the Laundry room ceiling from a previous pipe leak above the wash tub sink. Evidence of prior water penetration is noted- Seen at Depicted is a stained ceiling tile.

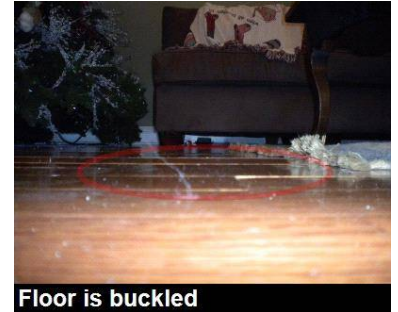
The floor covering material is hardwood. Fair - Material is worn, with some age.

Floor is buckled

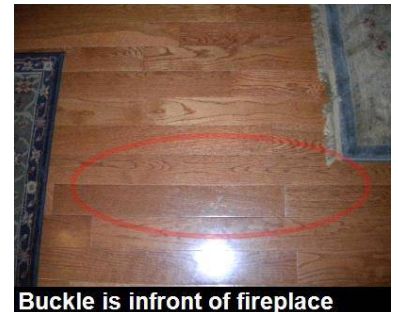
The floor in this room is in need of some attention or repair. Movement was noted in the floor. Determination of the cause and repairs are needed are uncertain.

Buckle is in front of fireplace

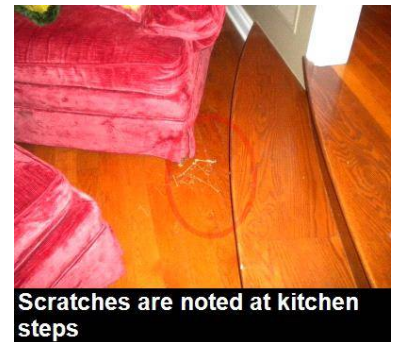
Fair - Material is worn, with some age. Scratches can be sanded and refinished.

Scratches are noted at kitchen steps

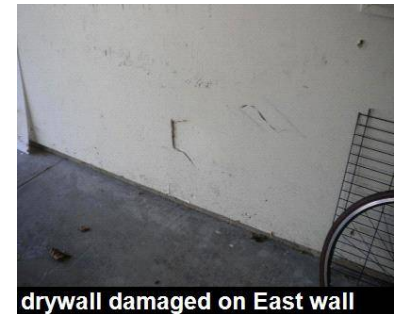
RR. Damage noted.

drywall damaged on East wall
