Visual Pro Home Inspections
6239 Eastmoor Road
Bloomfield Hills MI 48301
248-688-7918
vincentcameron@VisualProHomeInspections.com

Confidential Inspection Report

2325
Birmingham, MI 48009

October 10, 2014

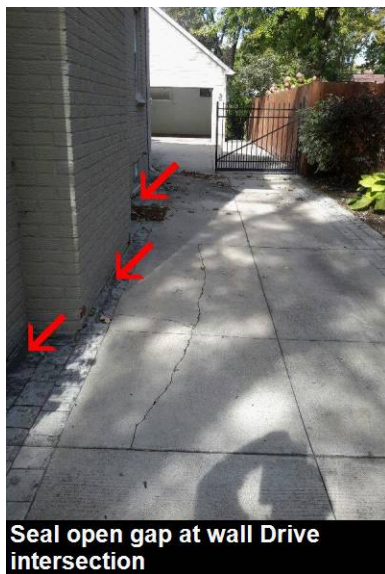
The building site is generally flat, sloping gently, Grade at foundation appears serviceable. However the seal at the wall / drive intersection needs repair.

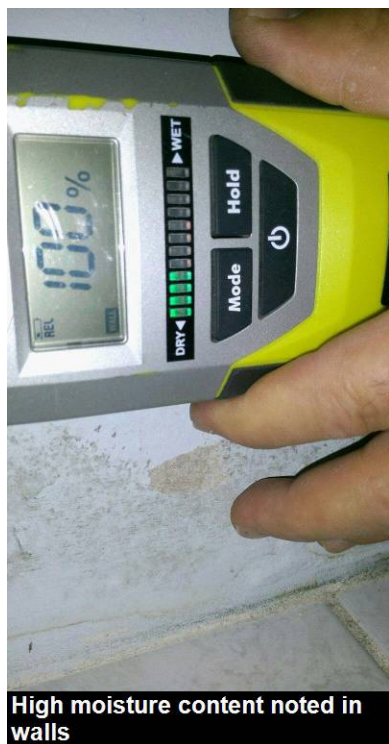
Yes - Higher than normal moisture levels were noted on the exposed areas of the interior basement walls, and attention is needed to determine the cause and best cure. High moisture content in the exterior walls can lead to mildew and wood rot in high concentrations. The moisture content noted is high enough to cause either or both. Staining was observed:

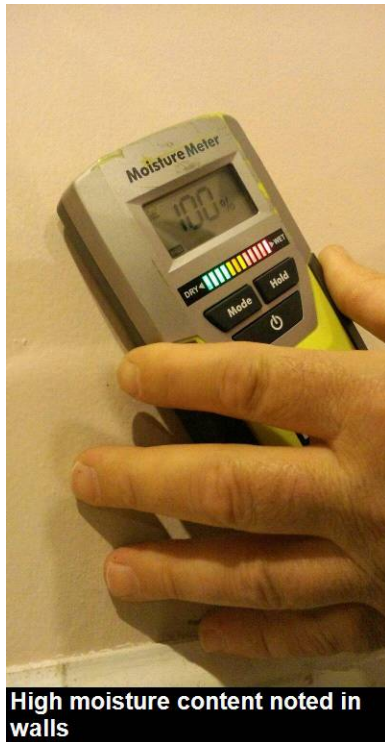
Yes - Higher than normal moisture levels were noted on the exposed areas of the interior basement walls, and attention is needed to determine the cause and best cure. High moisture content in the exterior walls can lead to mildew and wood rot in high concentrations. The moisture content noted is high enough to cause either or both. There is evidence of water entry or damage in the crawlspace level. **Action Necessary** - At the time of the inspection there was water present. Immediate action is necessary to make repairs and to stop further damage. Estimates from reputable contractors are needed. Staining was observed: Evidence of present water penetration is noted- Seen at.

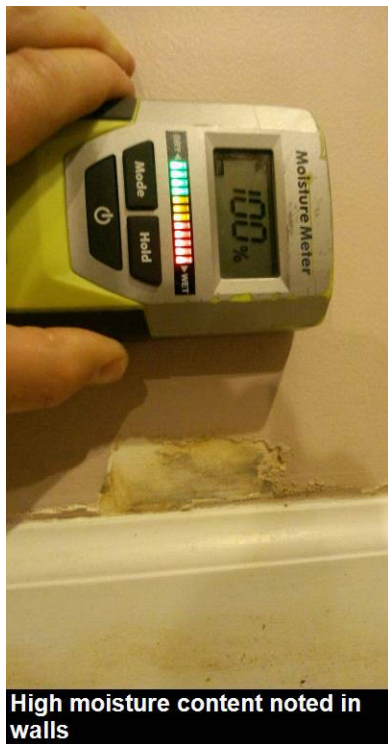
Yes - Higher than normal moisture levels were noted on the exposed areas of the interior basement walls, and attention is needed to determine the cause and best cure. High moisture content in the exterior walls can lead to mildew and wood rot in high concentrations. The moisture content noted is high enough to cause either or both. There is evidence of water entry or damage in the crawlspace level. **Action Necessary** - At the time of the inspection there was water present. Immediate action is necessary to make repairs and to stop further damage. Estimates from reputable contractors are needed. Staining was observed: Evidence of present water penetration is noted- Seen at.

High moisture content noted in walls

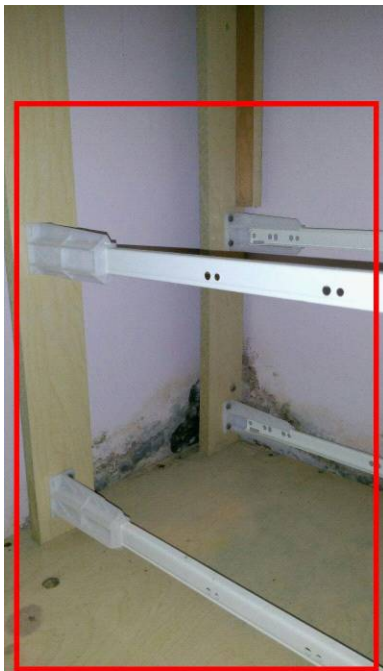
Damage is noted at counters/cabinets. Mold growth was noted. Swabs have been delivered to the lab for toxic screening.

Heavy mold growth noted

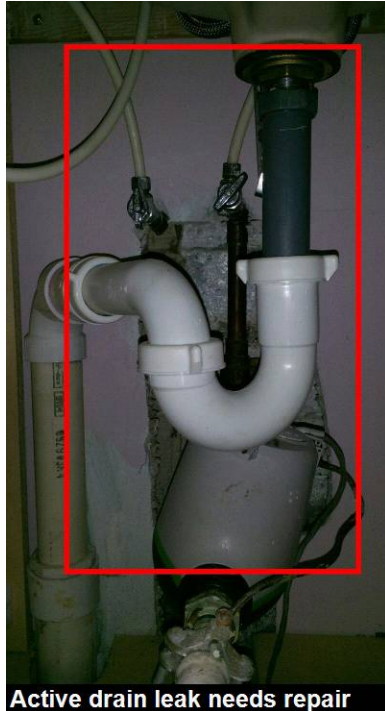
The following problems were noted at the drain: Leakage is noted at the drain. A licensed plumber should be called to make further evaluation and repairs as needed. Damage is noted at counters/cabinets.

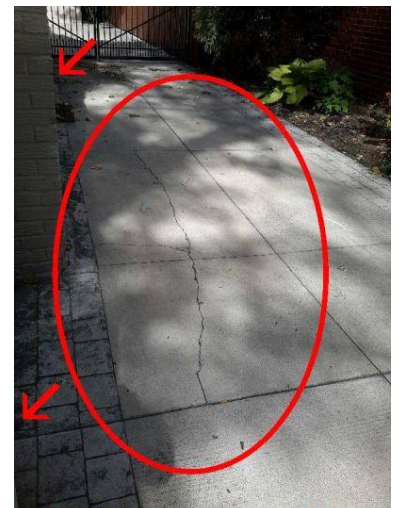
Concrete, **Observations-** Cracks noted are typical. The joint between the home and the drive needs to be resealed so as not to allow runoff water to seep down the basement walls on the East side of the home.

Noted Cracks are typical / Seal Drive Wall

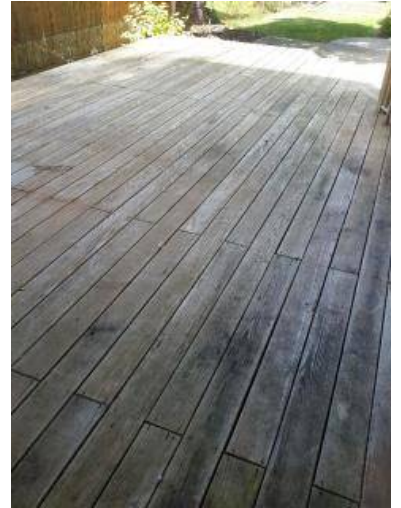
- ☒ ☐ ☐ Wood, Wood deck structure is in moderate condition and in need of general maintenance such as power washing / sealing and or securing of boards and handrails.

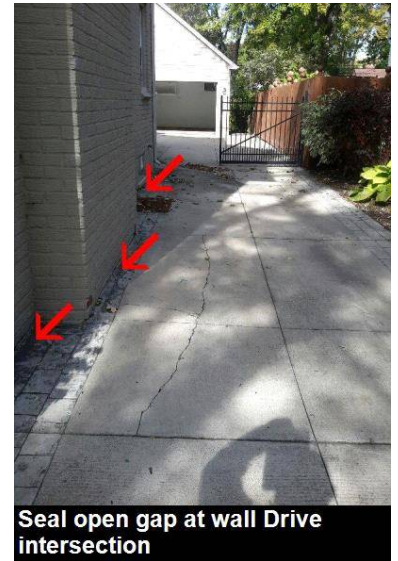
- ☐ ☐ ☒ The building site is generally flat, sloping gently, Grade at foundation appears serviceable. However the seal at the wall / drive intersection needs repair.

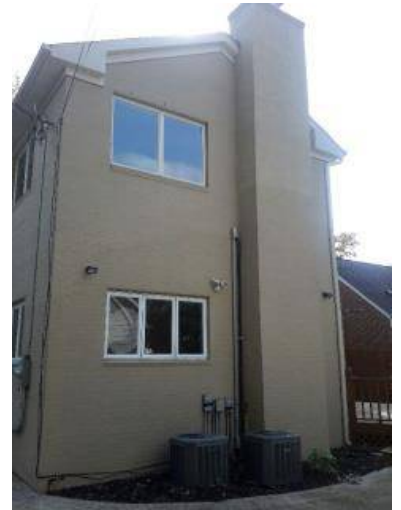
- ☐ ☒ ☐ Walls are constructed with Brick.
Cracks noted are typical.

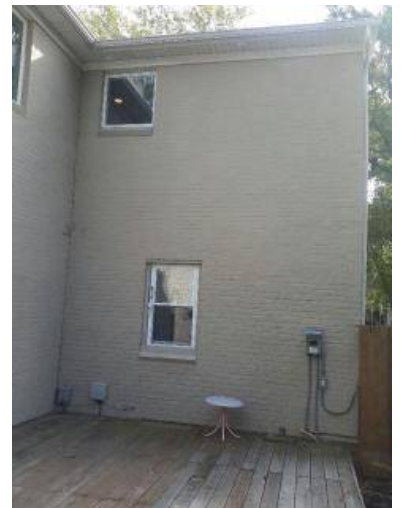
- ☐ ☒ ☐ Walls are constructed with Brick.
Cracks noted are typical.

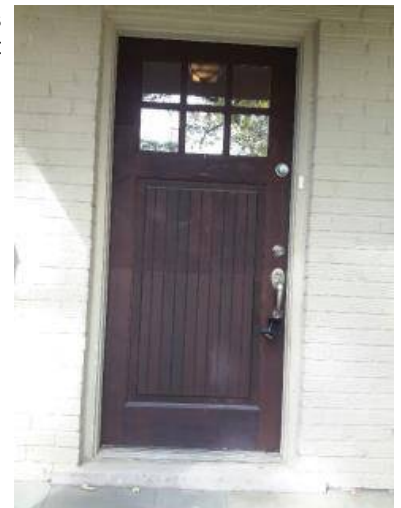
Wood, with glass. Hardware is operational, Doorframes are not square. Some binding is noted, Doorbell button is missing.

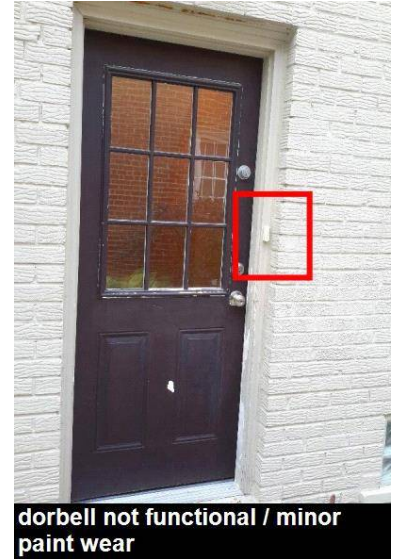
- ☐ ☒ ☐ Metal, with glass. Damage viewed, Hardware is operational, Doorbell button is Doorbell is inoperative.

- OK MM RR
☐ ☒ ☐ Trim around door should be scrapped and repainted.

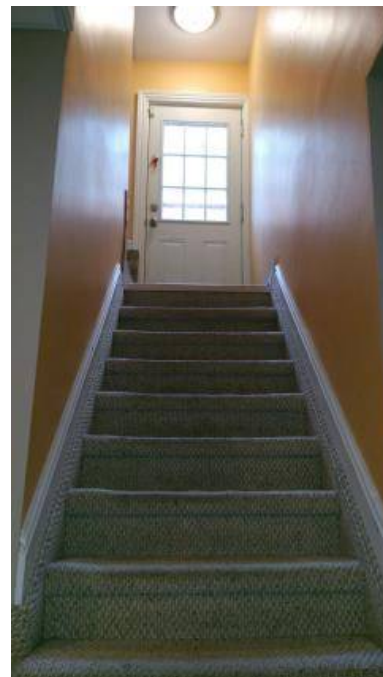
Basement is fully accessible and finished. Stairs are serviceable, Finish grade construction, carpeted. There is either no handrail installed, or it needs repair or replacement.

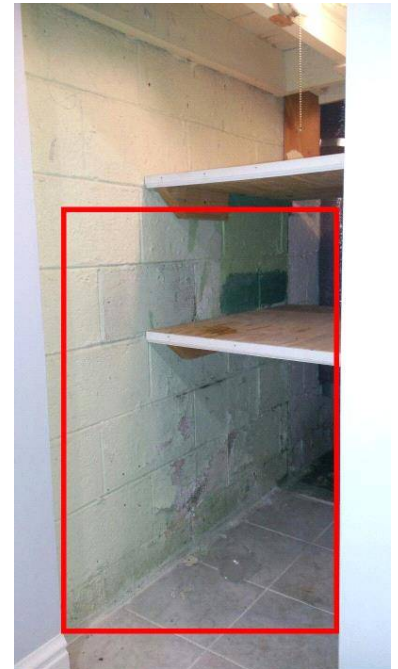
- ☐ ☒ ☐ Wall Materials are concrete block. Damage/deterioration is noted.

Moisture damage is noted

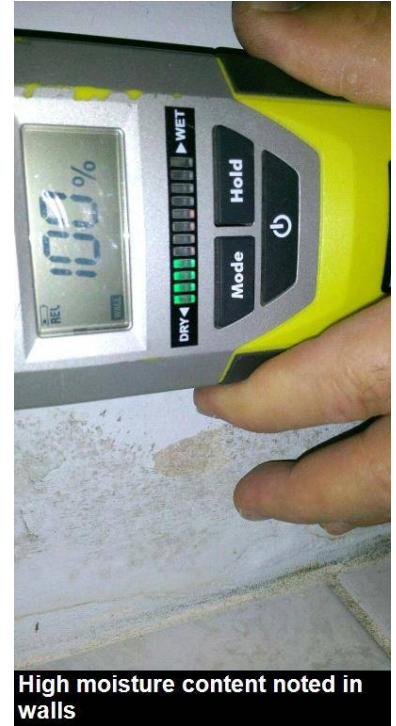
- ☐ ☐ ☒ Yes - Higher than normal moisture levels were noted on the exposed areas of the interior basement walls, and attention is needed to determine the cause and best cure. High moisture content in the exterior walls can lead to mildew and wood rot in high concentrations. The moisture content noted is high enough to cause either or both. Staining was observed:

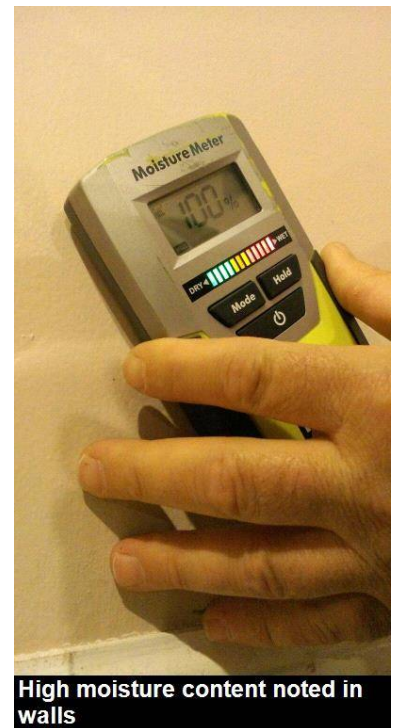
- ☐ ☐ ☒ Yes - Higher than normal moisture levels were noted on the exposed areas of the interior basement walls, and attention is needed to determine the cause and best cure. High moisture content in the exterior walls can lead to mildew and wood rot in high concentrations. The moisture content noted is high enough to cause either or both. There is evidence of water entry or damage in the crawlspace level. **Action Necessary** - At the time of the inspection there was water present. Immediate action is necessary to make repairs and to stop further damage. Estimates from reputable contractors are needed. Staining was observed: Evidence of present water penetration is noted- Seen at.

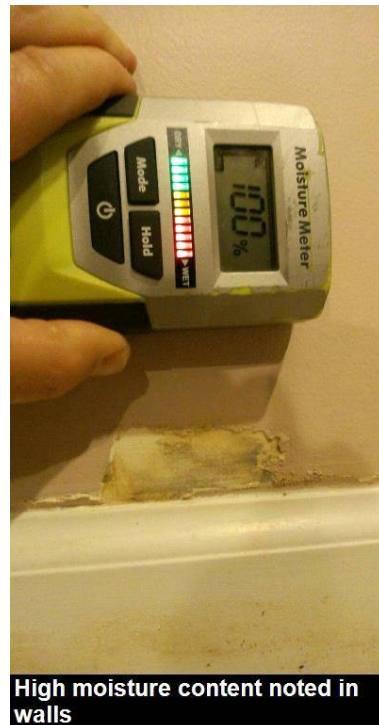
- ☐ ☐ ☒ Yes - Higher than normal moisture levels were noted on the exposed areas of the interior basement walls, and attention is needed to determine the cause and best cure. High moisture content in the exterior walls can lead to mildew and wood rot in high concentrations. The moisture content noted is high enough to cause either or both. There is evidence of water entry or damage in the crawlspace level. **Action Necessary** - At the time of the inspection there was water present. Immediate action is necessary to make repairs and to stop further damage. Estimates from reputable contractors are needed. Staining was observed: Evidence of present water penetration is noted- Seen at.

High moisture content noted in walls

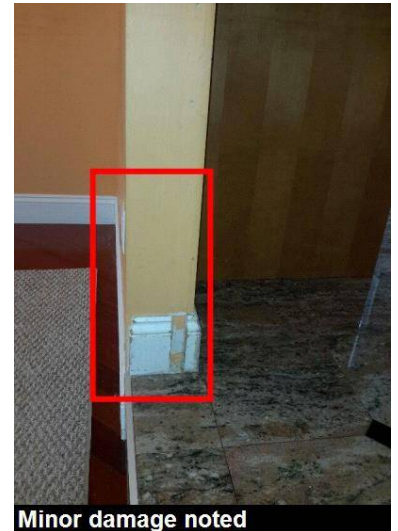
☐ ☒ ☐ Damaged noted.

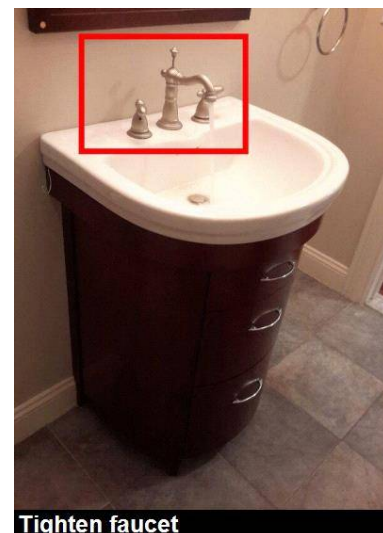
- OK MM RR
☐ ☒ ☐ The following problems were noted at the sink: Counters/cabinets appear serviceable, Functional with no leaks detected. Faucet loose. ...should be tightened.

**Tighten faucet***Bath Between Bedrooms:*

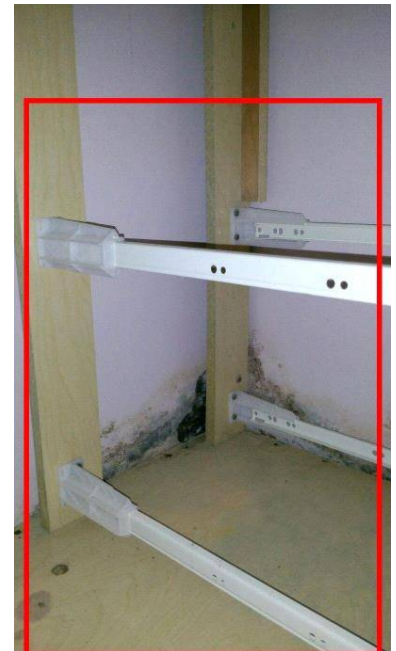
- OK MM RR
☐ ☐ ☒ Damage is noted at counters/cabinets. Mold growth was noted. Swabs have been delivered to the lab for toxic screening.

Heavy mold growth noted

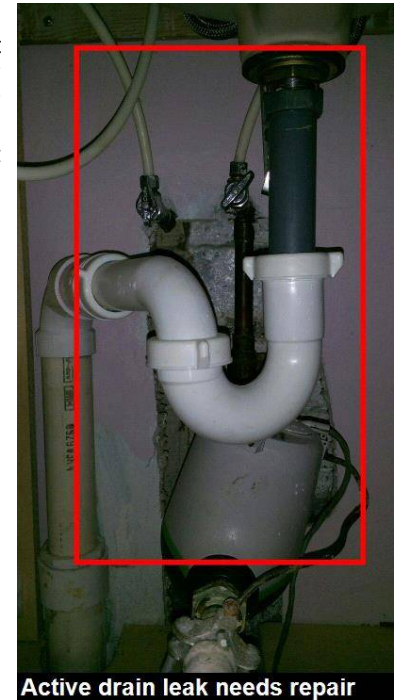
The following problems were noted at the drain: Leakage is noted at the drain. A licensed plumber should be called to make further evaluation and repairs as needed. Damage is noted at counters/cabinets.

Active drain leak needs repair

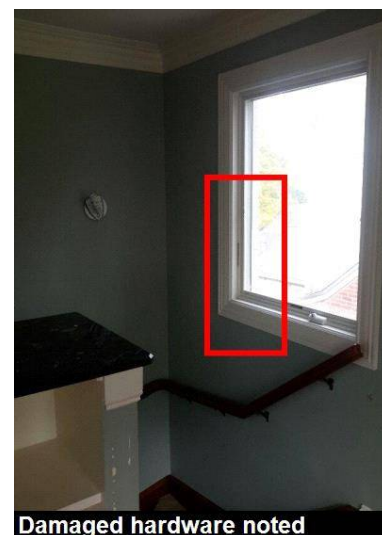
At least one window or associated hardware in this room needs repair. Locking hardware needs repair or replacement.

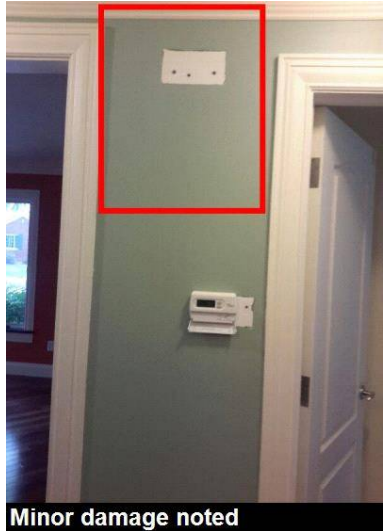
☐ ☒ ☐ Damaged noted.

Minor damage noted

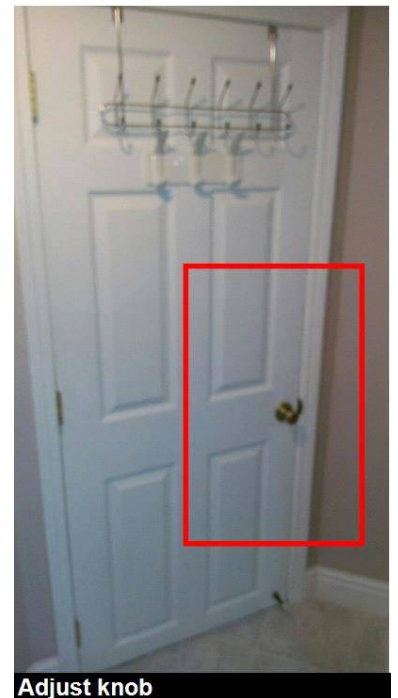
Hardware operational, Door hardware needs adjustment or repair, as the latch or strike plate needs adjustment so that the door will latch correctly.

Adjust knob

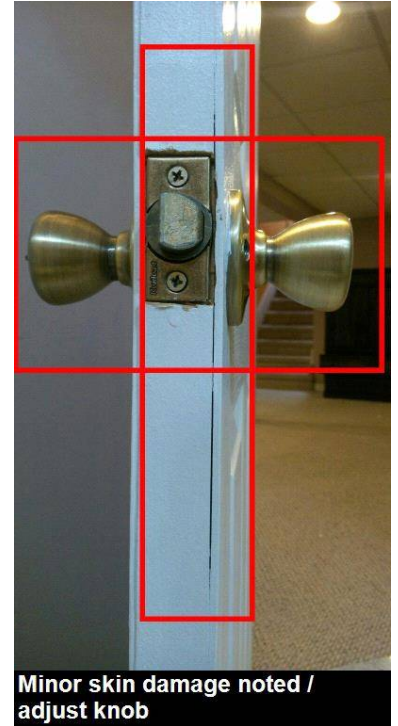
☐ ☒ ☐ Minor skin damage noted.

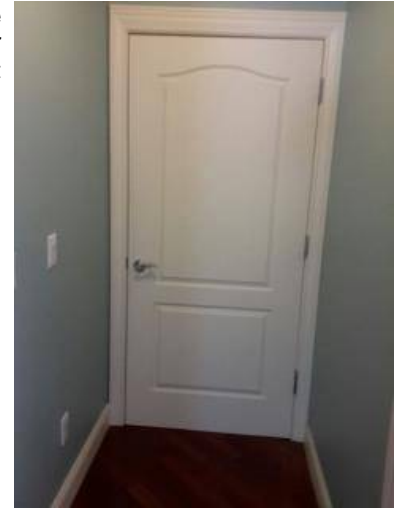
General condition appears serviceable, Hardware operational, Door hardware needs adjustment or repair, as the latch or strike plate needs adjustment so that the door will latch correctly.

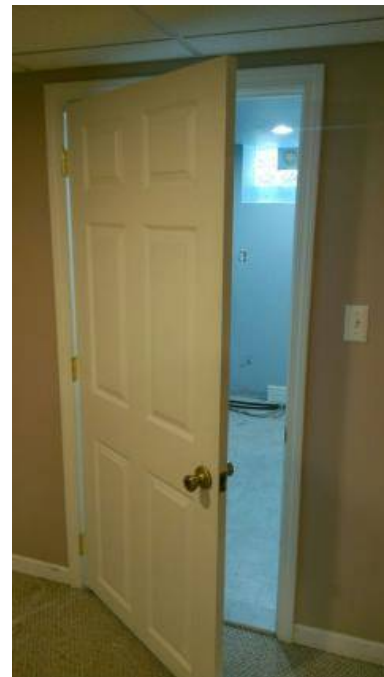
- ☐ ☒ ☐ General condition appears serviceable, Hardware operational, Doors rub/stick/won't latch, Door hardware needs adjustment or repair, as the doorknob assembly needs to be replaced.

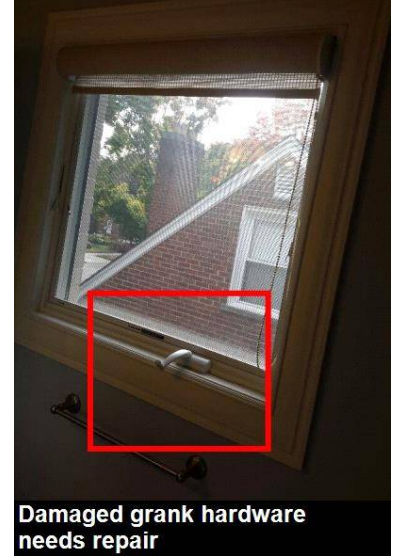
At least one window or associated hardware in this room needs repair.
Crank for window is broken, won't open the window.

Damaged crank hardware needs repair

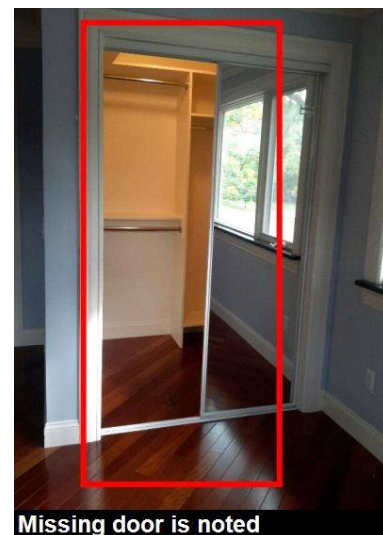
☐ ☐ ☒ General condition appears serviceable, The closet is lighted, One of closet doors are missing.
