Report: 0007608

Confidential Inspection Report

1032 Whittier
Grosse Pointe, MI 48230

November 25, 2011

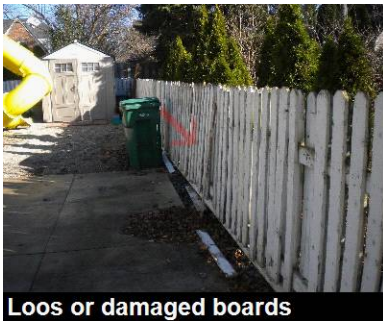
10. RR.

Missing boards on west fence

Repair missing boards

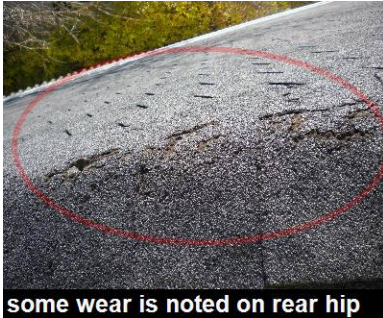
14. RR. Damage noted.

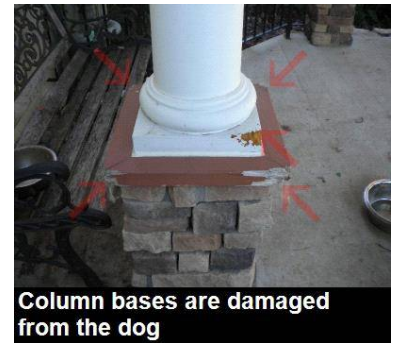
RR.

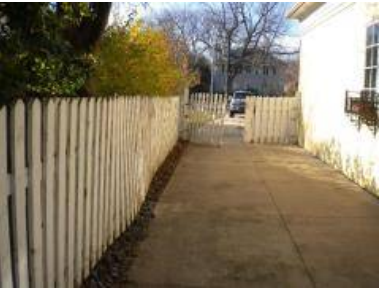
Loos or damaged boards

MM.

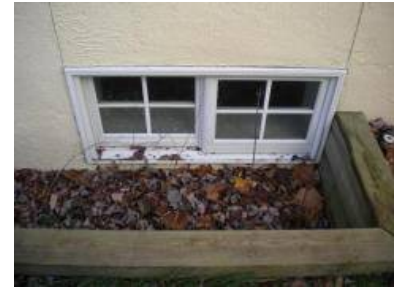
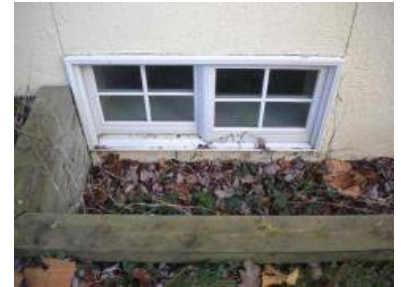
Window wells are uncovered. Make inquiry with seller about installed drainage systems.

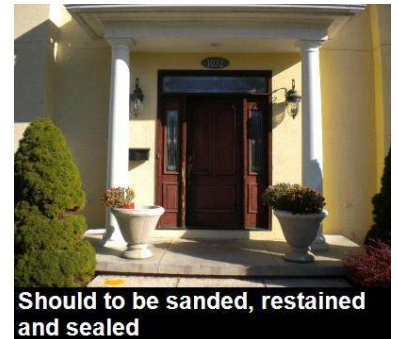
Wood, with glass. MM.

Should to be sanded, restained and sealed

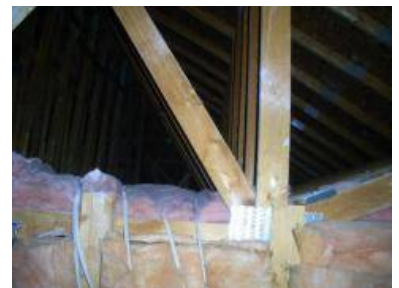
OK.

15 inches, R-38.

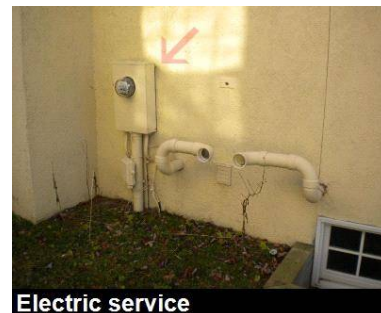
Electric service

OK, Underground, 110/220 Volt,
Circuit breakers, Appears
serviceable.

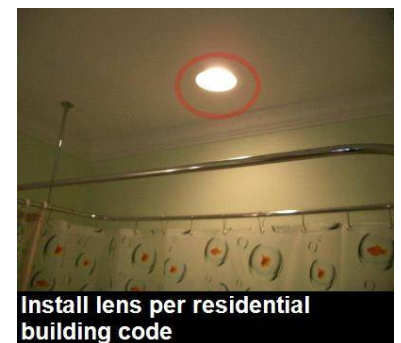
Other Bath:

Cover needs to be installed over tub location.

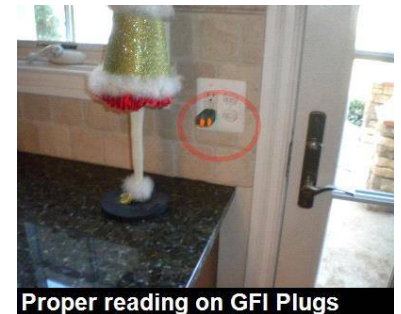
Proper reading on GFI Plugs

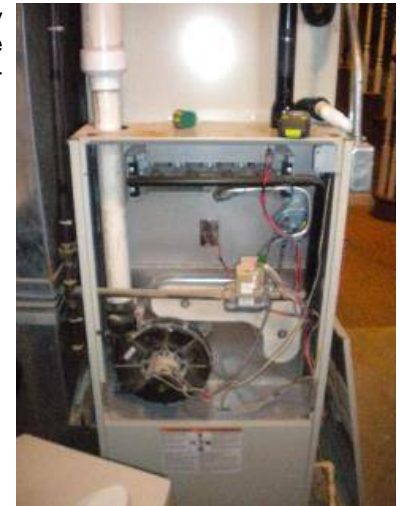
Forced Air. The furnace is a newer high efficiency type with a fan installed in the vent pipe to push the burnt flue gases up and out the flue. Location-Basement.

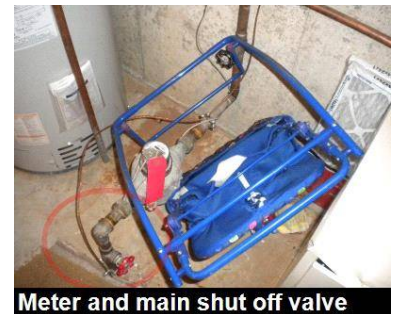
Meter and main shut off valve

Water meter is located in the basement.

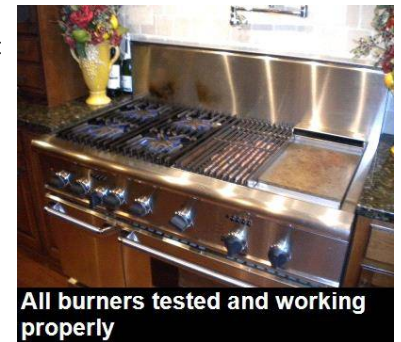
OK. Gas, with electric ignition. Separate cook top, Built-in unit with grill/fan, Appears serviceable.

All burners tested and working properly

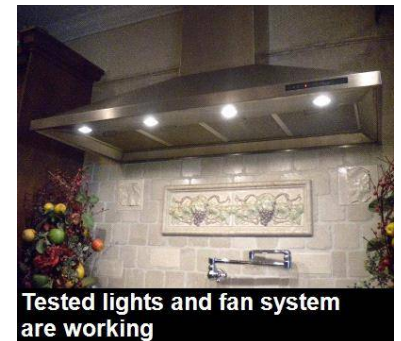
OK, External, Fan/Hood operational.

Tested lights and fan system are working

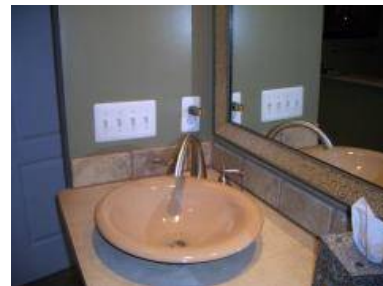
Master Bath:

OK, The following problems were noted at the sink:

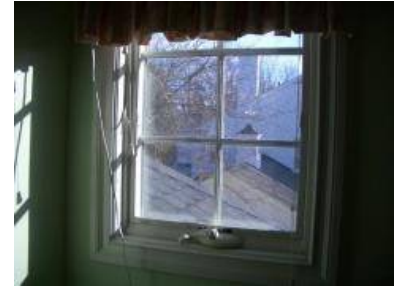
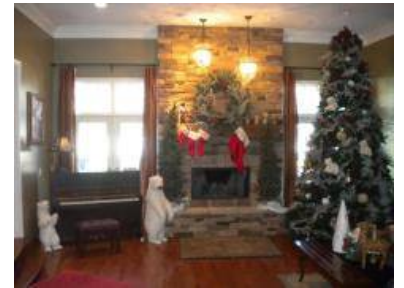
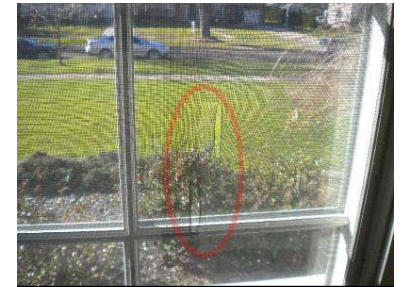
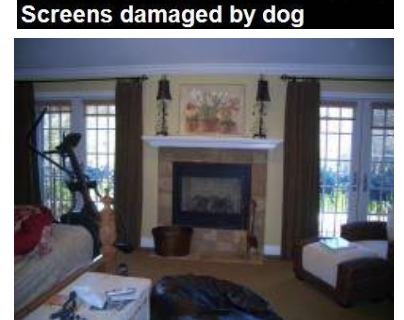
The screen for this window needs repair.

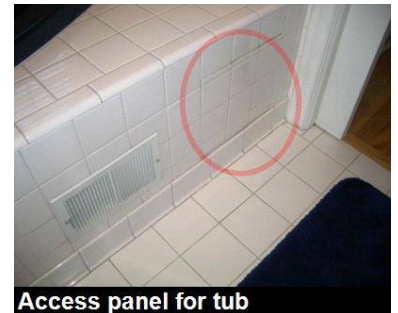
Bath Between Bedrooms:

The floor covering material is Glazed ceramic tile Good - The floor covering is newer, and it should provide years of service.

Access panel for tub

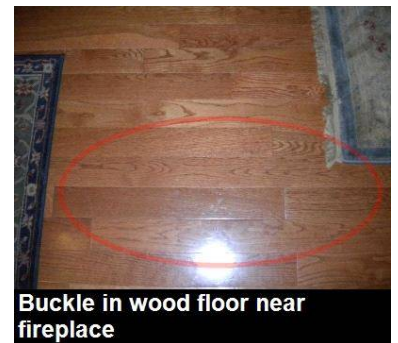
Entry / Foyer / Hall:

The floor covering material is hardwood. carpet. Good - The floor covering is newer, and it should provide years of service.

Buckle in wood floor near fireplace

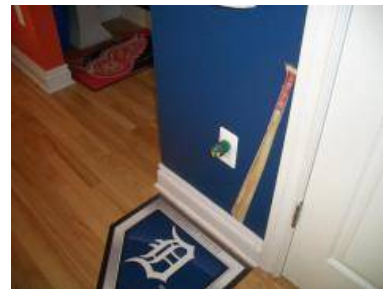
Bedroom #3:

The floor covering material is General condition appears serviceable hardwood. Good - The floor covering is newer, and it should provide years of service.

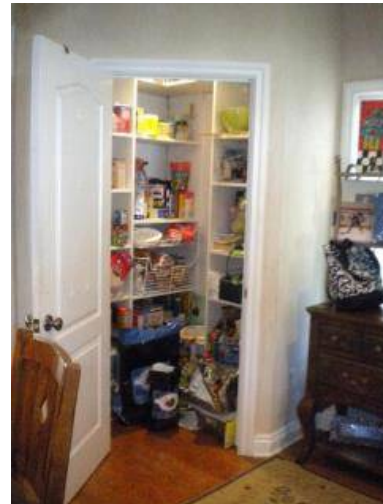
Kitchen Interior:

General condition appears serviceable, The closet is lighted.

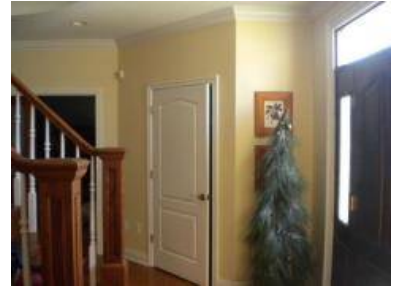
Entry / Foyer / Hall:

General condition appears serviceable.

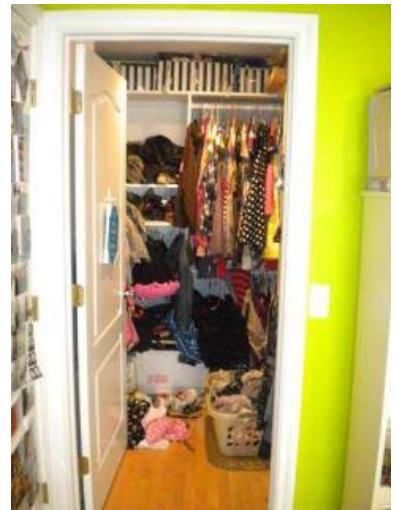
Bedroom #2:

General condition appears serviceable. The closet is lighted.

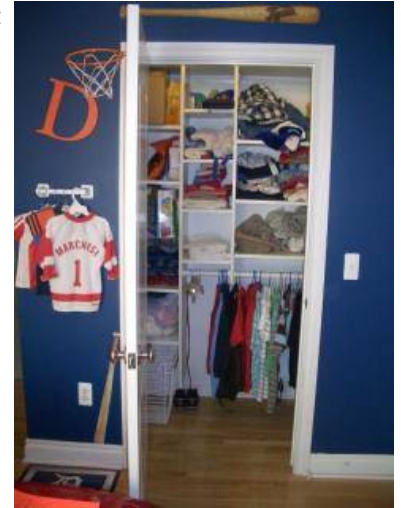
Bedroom #3:

General condition appears serviceable, The closet is lighted.

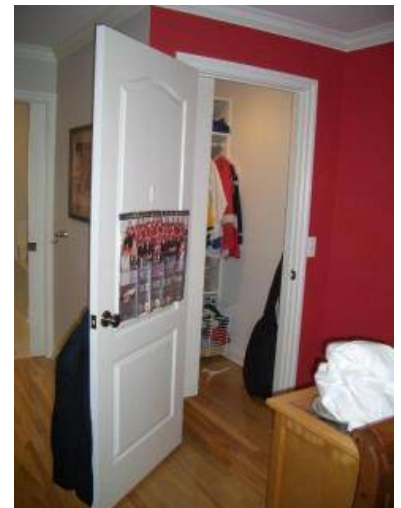
Other Room:

General condition appears serviceable.

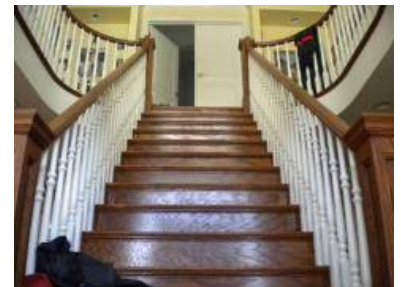
Stairs & Handrails:

OK. Interior stairs serviceable,
Stair handrail serviceable.

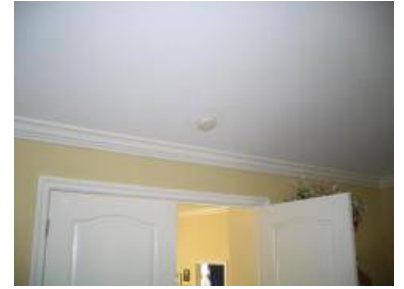
Master Bedroom:

There is a functional smoke detector installed in this room.

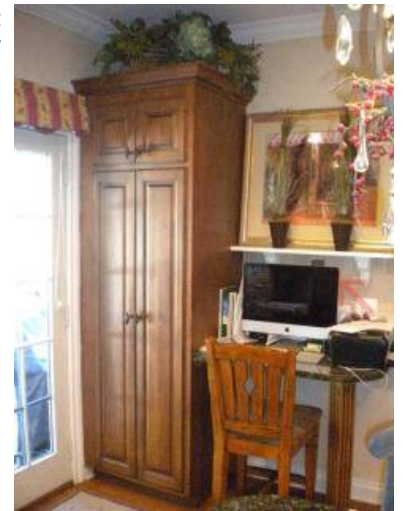
Kitchen Interior:

There is a telephone jack installed in this room. It may or may not be functional. There is a computer access jack installed in this room. It may or may not be functional.

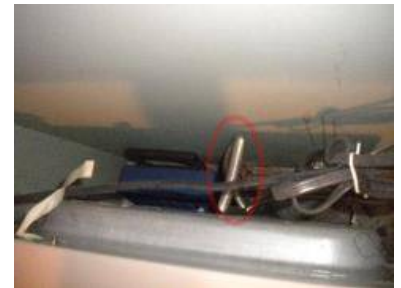
Fuel System:

OK. Gas service pipe is provided.

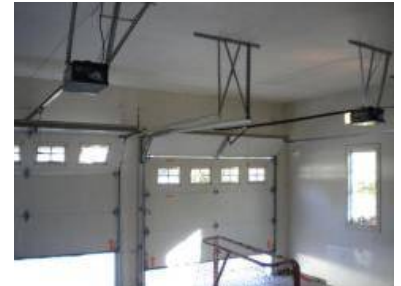
OK, General condition appears serviceable.

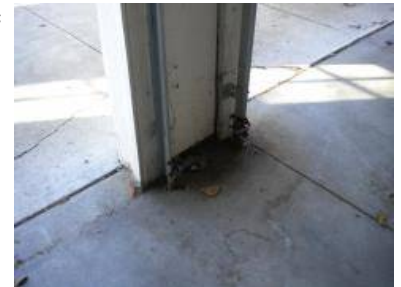
Automatic Opener:

OK, operational, Automatic reverse feature is operational.

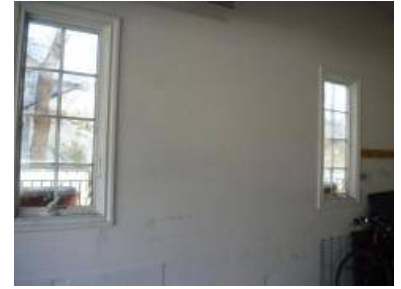
Walls:

OK. General condition appears serviceable.

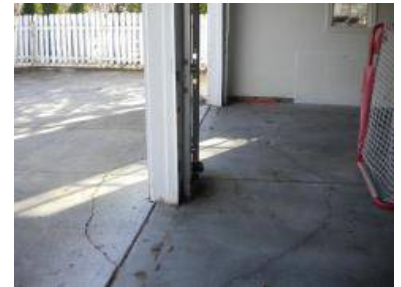
OK, General condition appears serviceable, Typical cracks noted.
