Visual Pro Home Inspections
6239 Eastmoor Road
Bloomfield Hills MI 48301
248-688-7918
vincentcameron@VisualProHomeInspections.com

Confidential Inspection Report

2325
Birmingham, MI 48009

October 10, 2014

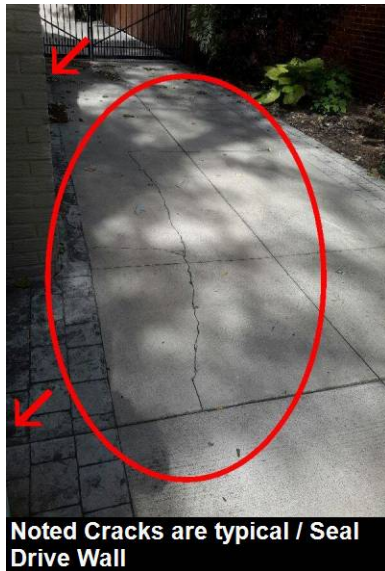
Concrete, **Observations-** Cracks noted are typical. The joint between the home and the drive needs to be resealed so as not to allow runoff water to seep down the basement walls on the East side of the home.

The building site is generally flat, sloping gently, Grade at foundation appears serviceable. However the seal at the wall / drive intersection needs repair.

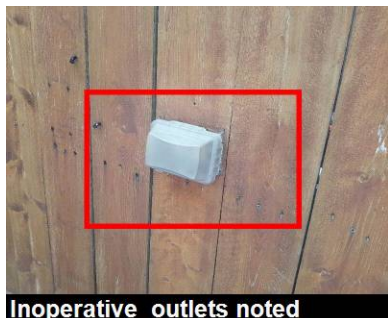
Inoperative electrical outlet noted.

Inoperative outlets noted

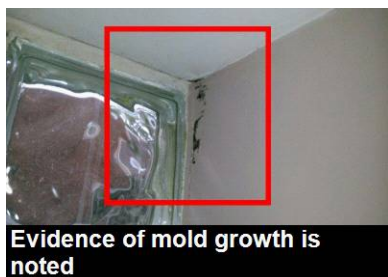
Wall Materials are concrete block and drywall. Damage/deterioration is noted.

Evidence of mold growth is noted

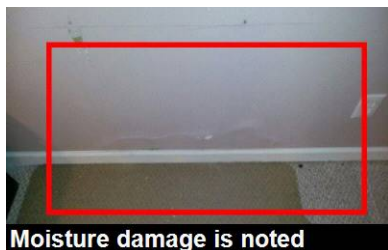
Wall Materials are drywall. Damage/deterioration is noted. Toxic mold was found in the lower level walls in the Laundry room, Bathroom, and living area. Lab work was completed and a specialist was consulted on the remediation of the mold. It is anticipated that the expenses for remediation as well as reconstruction of the basement walls, ceiling, paint, carpets as well as a perimeter drain system will run nearly \$18,000.

Moisture damage is noted

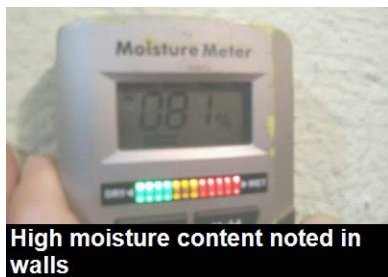
High moisture content noted in walls

Yes - Higher than normal moisture levels were noted on the exposed areas of the interior basement walls, and attention is needed to determine the cause and best cure. High moisture content in the exterior walls can lead to mildew and wood rot in high concentrations. The moisture content noted is high enough to cause either or both. Staining was observed:

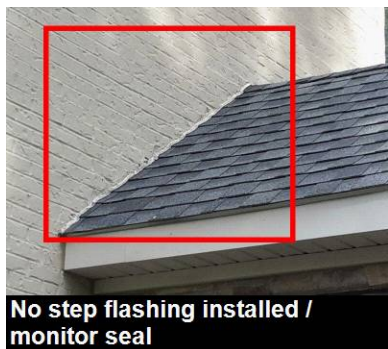
Install step flashing against brick.

Install step flashing against brick.

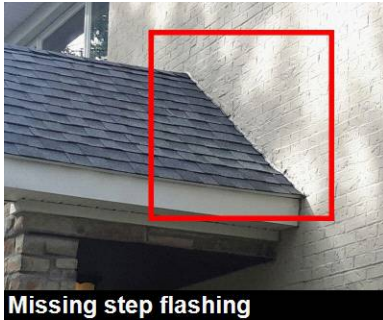
Missing step flashing

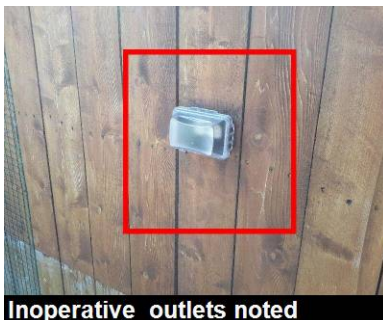
Inoperative electrical outlet noted.

Inoperative outlets noted

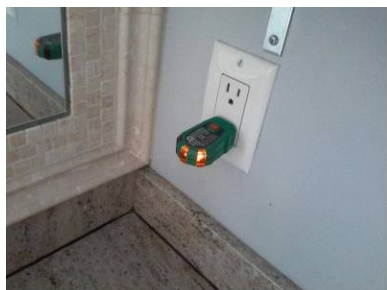
A representative sampling of switches and outlets was tested. As a whole, outlets and switches throughout the room are in serviceable condition. GFCI not operational, This outlet is not functioning properly.

GFI Outlet failed trip test

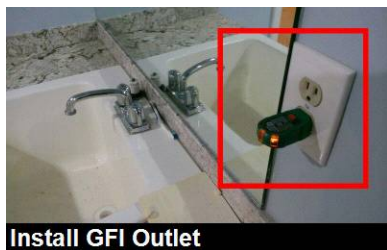
Install GFI Outlet

Ground Fault Circuit Interrupter (GFCI) outlets are recommended for installation at exterior, garage, bath rooms & kitchen outlets.

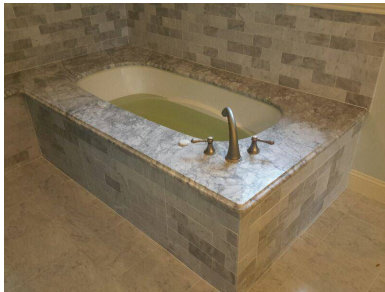
Ceramic Tile, Hydro spa not functioning at time of inspection. Either bad motor in tub or bad G F I breaker.

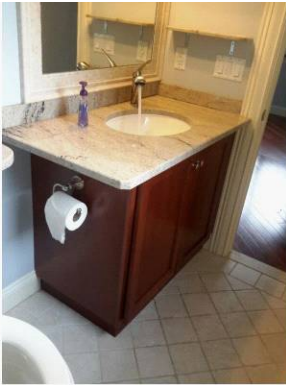
Mold damage noted

Damage is noted at counters/cabinets. Mold growth was noted. Swabs have been delivered to the lab for toxic screening.

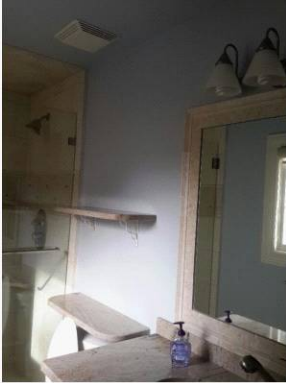
Hidden Damage - The cracks in the walls may be an indication of hidden structural problems. Further investigation as to the cause is needed. Walls are in good condition with normal wear.

Hidden mold damage noted

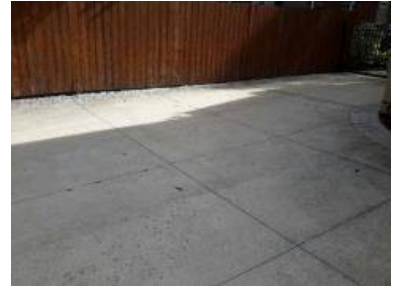
☐ ☒ ☐ Concrete, **Observations-** Cracks
noted are typical, Surface
raised/settled.

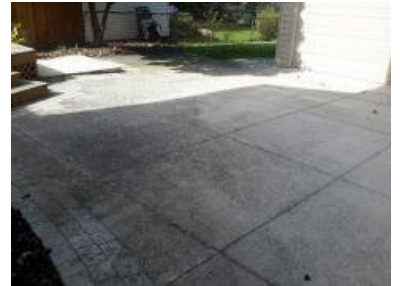
OK MM RR
☐ ☒ ☐ Concrete, **Observations-** Cracks
noted are typical, Surface
raised/settled.

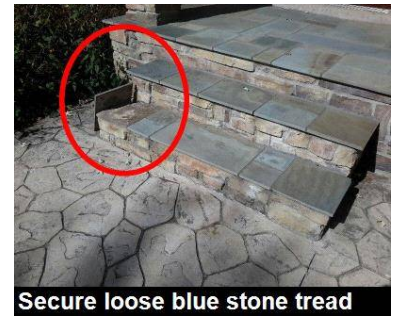
Steps are constructed primarily of concrete, **Observations-** Loose tile at end of bottom tread needs to be re secured.

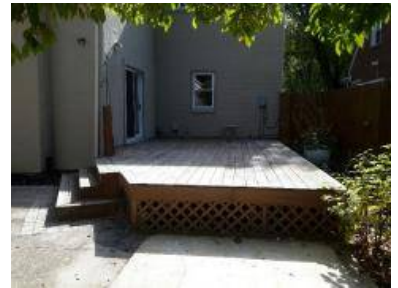
☒ ☐ ☐ Wood, Wood deck structure is in moderate condition and in need of general maintenance such as power washing / sealing and or securing of boards and handrails.

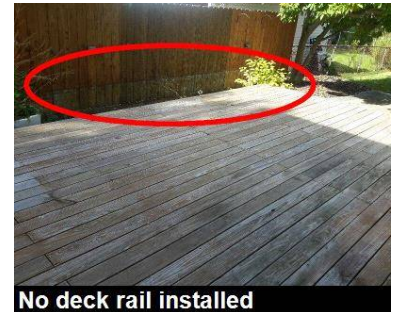
- OK MM RR
☐ ☒ ☐ Wood, No railing system installed.

No deck rail installed

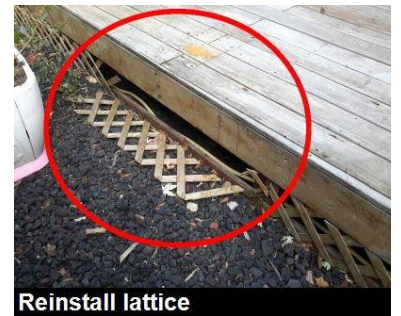
- ☐ ☒ ☐ Lattice skirting has fallen off.

Reinstall lattice

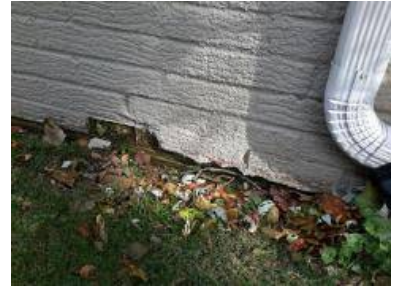
OK MM RR
☐ ☒ ☐ Walls are constructed with Brick.
Brick facing has fallen off.

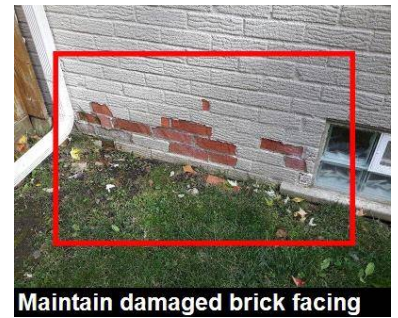
☐ ☒ ☐ Walls are constructed with Brick.
Brick facing has fallen off.

Maintain damaged brick facing

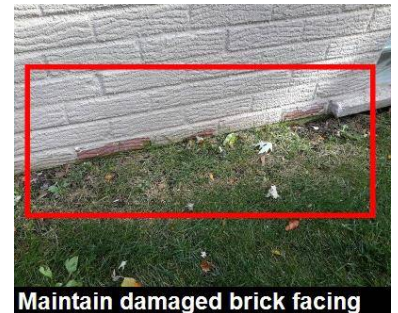
☐ ☒ ☐ Walls are constructed with Brick.
Brick facing has fallen off.

Maintain damaged brick facing

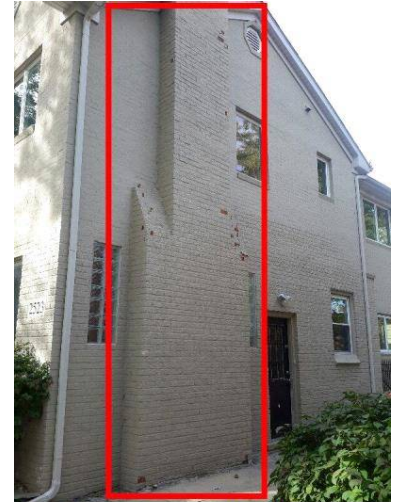
- ☐ ☒ ☐ Walls are constructed with Brick. Brick facing has fallen off in several areas.

Maintain damaged brick facing

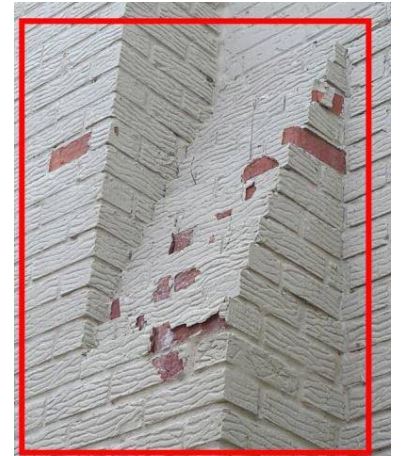
- OK MM RR
☐ ☒ ☐ Walls are constructed with Brick. Brick facing has fallen off.

Maintain damaged brick facing

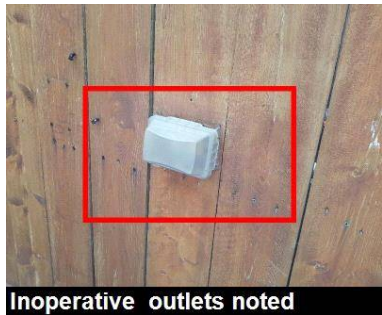
☐ ☐ ☒ Inoperative electrical outlet noted.

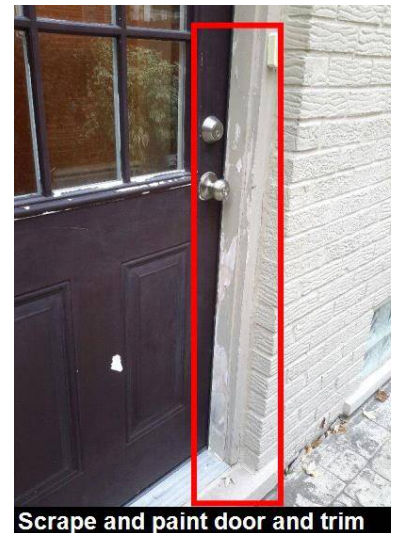
- OK MM RR
☐ ☒ ☐ Trim around door should be scrapped and repainted.

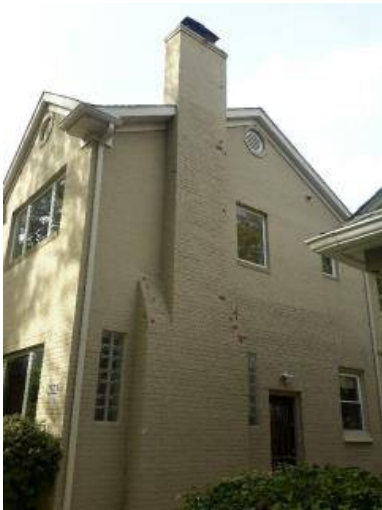
☐ ☒ ☐ Chimney is constructed of brick materials. Brick facing has fallen off in several areas.

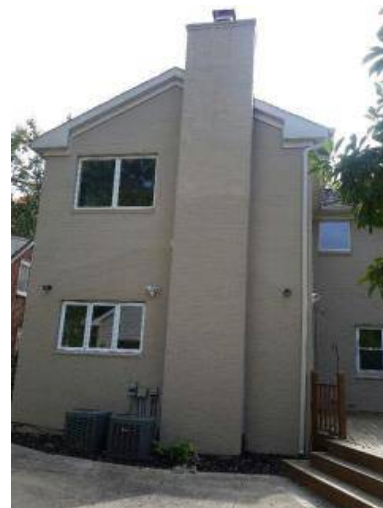
- ☐ ☒ ☐ Chimney is constructed of brick materials. Chimney needs repair of the following deficiencies: The chimney shows evidence of brick spalling. This condition should be addressed before further damage results. Cause is generally due to moisture getting into the bricks. This is a result of missing or cracked mortar.

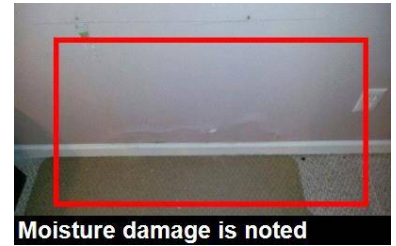
- ☐ ☐ ☒ Wall Materials are drywall. Damage/deterioration is noted. Toxic mold was found in the lower level walls in the Laundry room, Bathroom, and living area. Lab work was completed and a specialist was consulted on the remediation of the mold. It is anticipated that the expenses for remediation as well as reconstruction of the basement walls, ceiling, paint, carpets as well as a perimeter drain system will run nearly \$18,000.

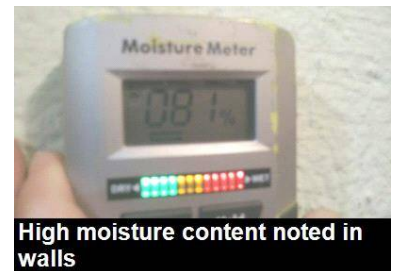
- ☐ ☐ ☒ Under the stairs.

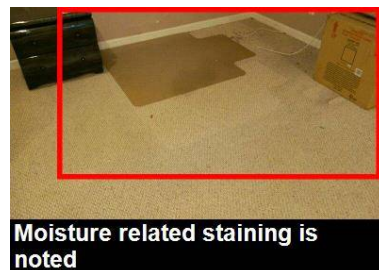
- ☐ ☒ ☐ Concrete, Carpet at finished areas, Symptoms of prior water entry exist.

Moisture related staining is noted

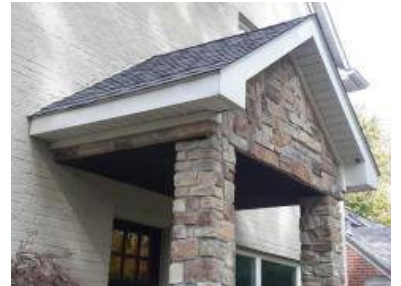
- OK MM RR
☐ ☒ ☐ None, Consider installing gutters and downspouts to help with site drainage.

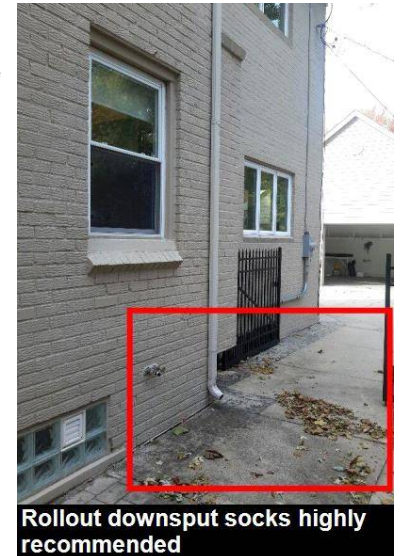
☐ ☐ ☒ Gutters and downspout materials are aluminum. Extend downspouts to route rainwater away from the building.
<http://rainguardusa.com/>

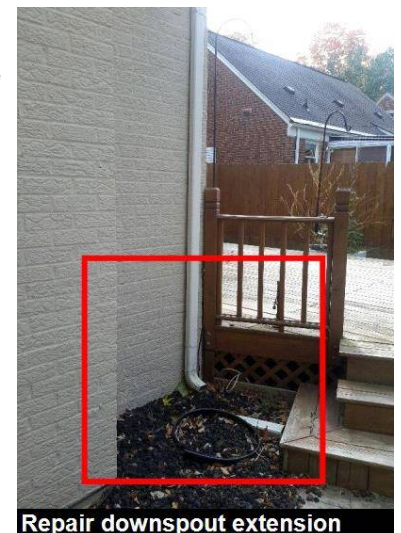
☐ ☒ ☐ Gutters and downspout materials are aluminum. Extend downspouts to route rainwater away from the building.
<http://rainguardusa.com/>

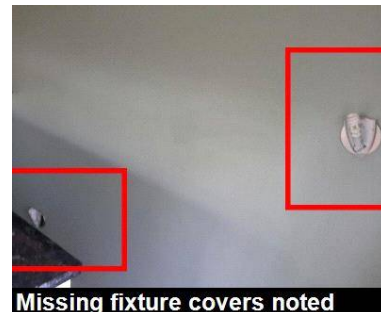
Entry / Foyer / Hall:

☐ ☒ ☐ Light fixtures missing cover.

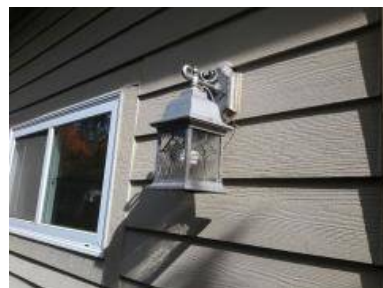
Garage Walls & Ceilings:

The light installed in this room did not function using the wall switch. I did not determine if the switch is bad or if the light bulb is bad.

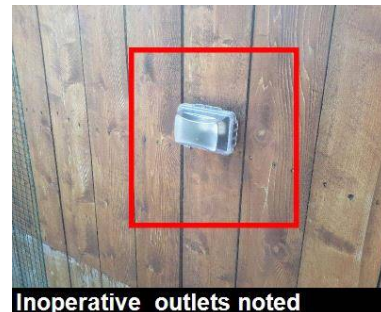
Exterior Walls:

☐ ☐ ☒ Inoperative electrical outlet noted.

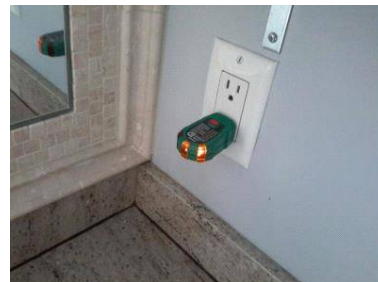
- ☐ ☐ ☒ A representative sampling of switches and outlets was tested. As a whole, outlets and switches throughout the room are in serviceable condition. GFCI not operational, This outlet is not functioning properly.

GFI Outlet failed trip test

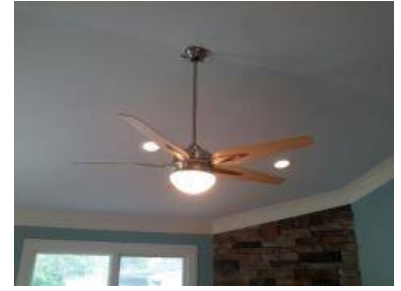
Master Bedroom:

The ceiling fan installed in this room did not function using normal controls. Inquire about remote control for fan.

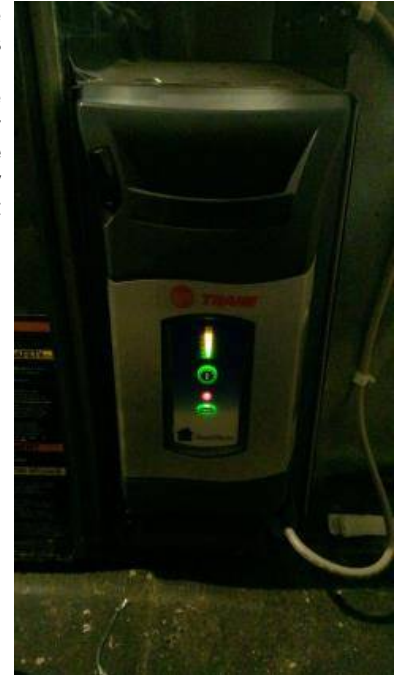
- ☒ ☐ ☐ A higher efficiency media type reusable filter is installed. This filter requires removal and cleaning at specific intervals. Follow the manufacturer's instructions for maintenance. Satisfactory - The filter is clean and correctly installed. It is recommended that the filter(s) be changed or cleaned every 30 to 45 days for best performance..

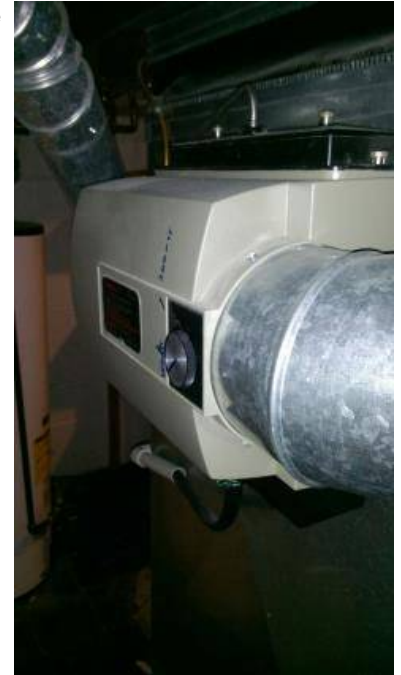
- ☒ ☐ ☐ Humidifier was functional. Change evaporator pad annually.

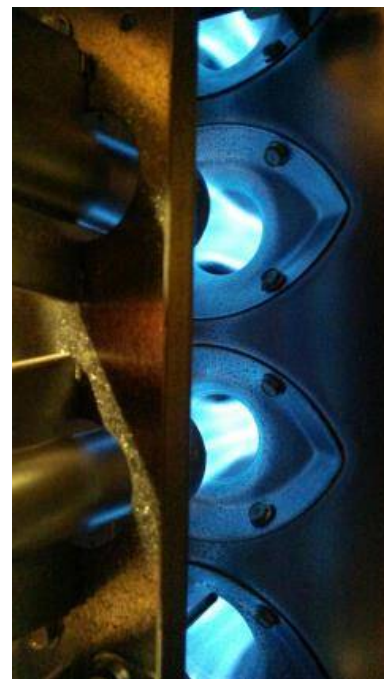
*Burners / Heat Exchangers:*☒ ☐ ☐

Burner Flame(s) appear typical.

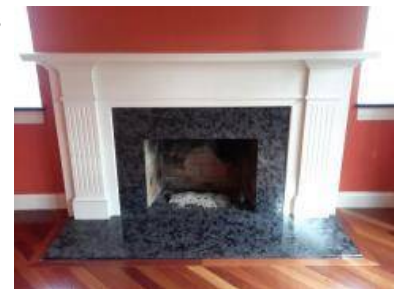
Entry / Foyer / Hall:

- ☐ ☒ ☐ Masonry, Gas - The fireplace is designed to use gas fuel only. No log set.

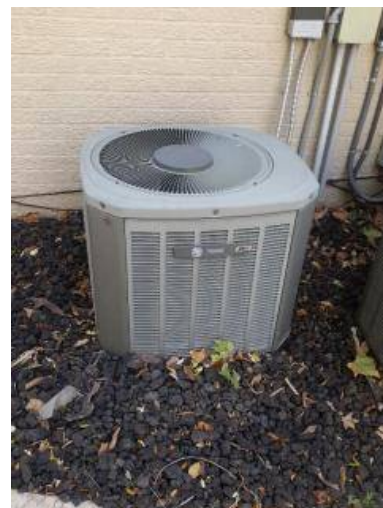
Primary Type:

Central, Split System- Outside air temperature was below 65 degrees. Unable to test system at this time.

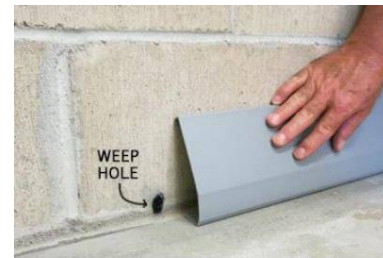
Highly Recommended.

None installed. One should be considered for installation due to the amount of moisture noted in the crawlspace or evidence of prior moisture condition.

Look at <http://waterproof.com/squidgee-dry-system.html>.

**This is the system I mentioned**

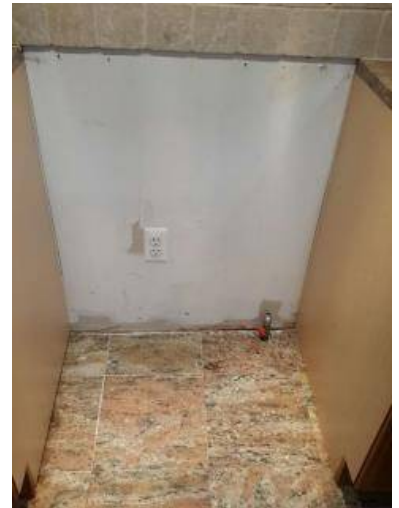
OK MM RR
☒ ☐ ☐ No range present at time of inspection.Gas hookup only.

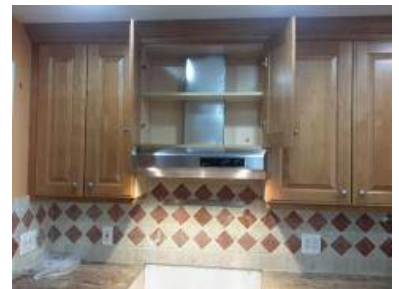
☒ ☐ ☐ External, Fan/Hood operational.

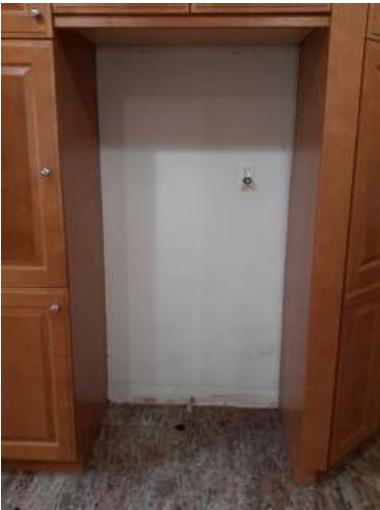
☒ ☐ ☐ No refrigerator present at time of the inspection.

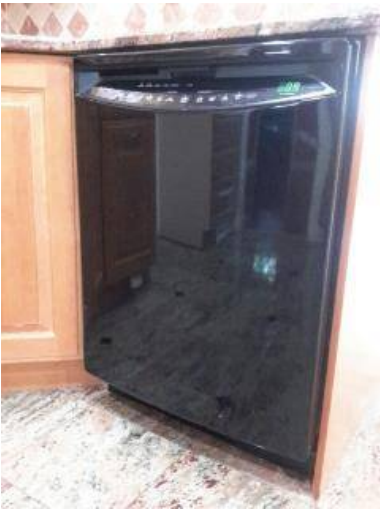
OK MM RR
☒ ☐ ☐ General condition appears serviceable.

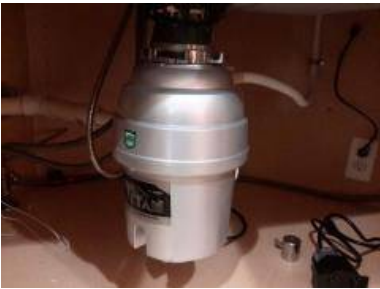
☒ ☐ ☐ General condition appears serviceable.

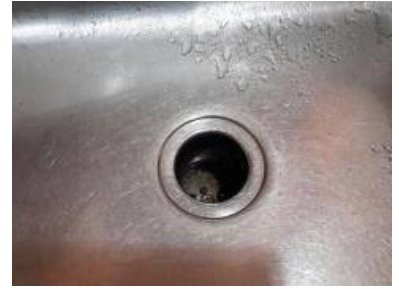
☐ ☒ ☐ Missing baffle for drain.

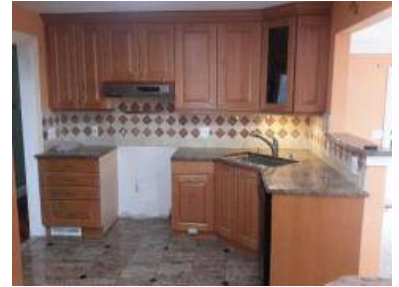
Counters are granite or marble with serviceable appearance, Cabinets appear serviceable with minor wear noted.

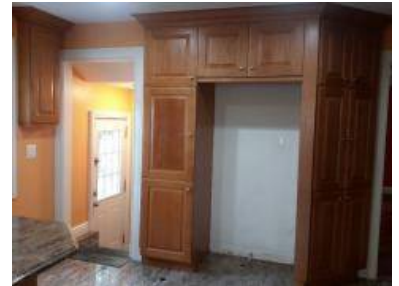
Counters are granite or marble with serviceable appearance, Cabinets appear serviceable with minor wear noted.

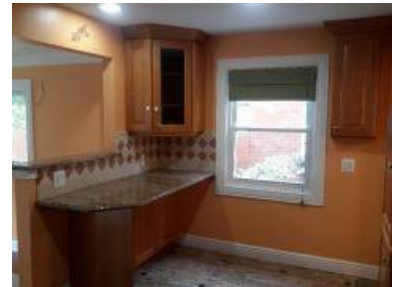
Counters are granite or marble with serviceable appearance, Cabinets appear serviceable with minor wear noted.

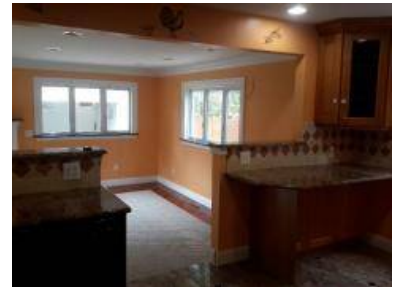
General condition appears serviceable, There is some minor cracking in the sheetrock. Most likely this is due to slight settlement or shrinkage.

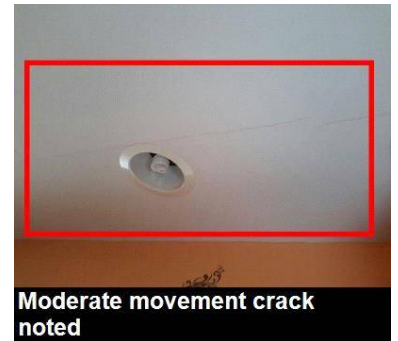
There is some minor cracking noted. Be sure to take note of any future movement. Most minor cracking is due to shrinkage of the construction materials.

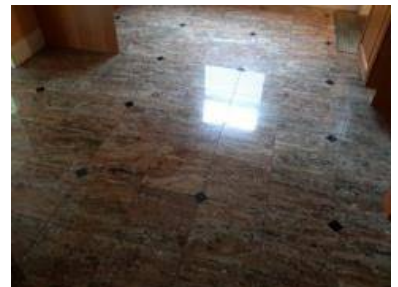
General condition appears serviceable, The floor covering material is glazed ceramic tile. Fair - Material is worn, with some age.

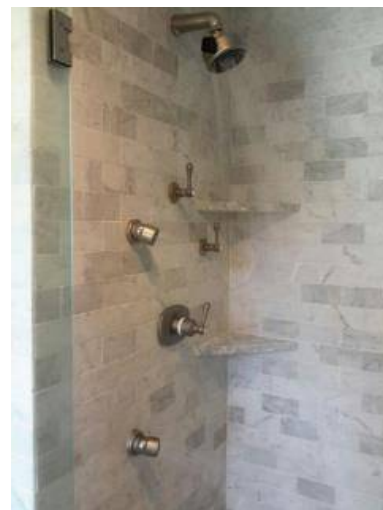
☒ ☐ ☐ Functional with no leaks detected.

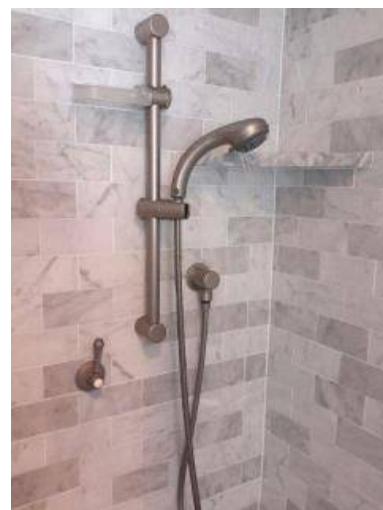
☒ ☐ ☐ Functional with no leaks detected.

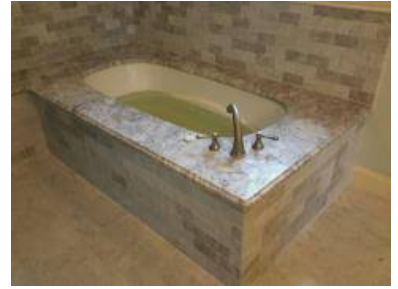
- ☐ ☐ ☒ Ceramic Tile, Hydro spa not functioning at time of inspection. Either bad motor in tub or bad G F I breaker.

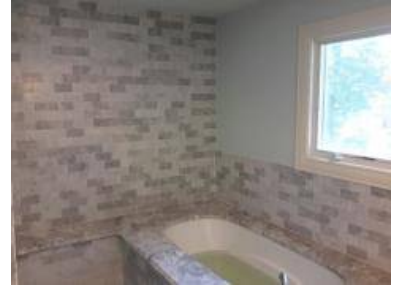
Walls are in good condition with normal wear.

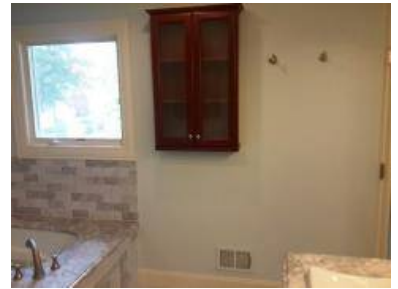
Walls are in good condition with normal wear.

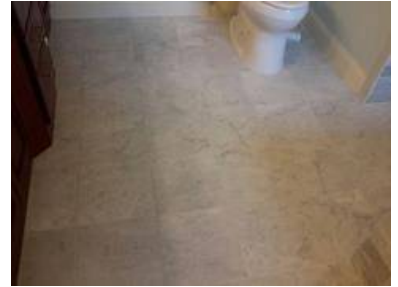
The floor covering material is Glazed ceramic tile
Fair - Material is worn, with some age.

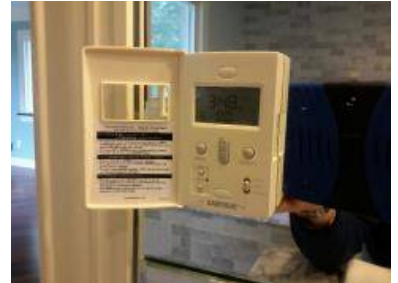
Heated marble floors.

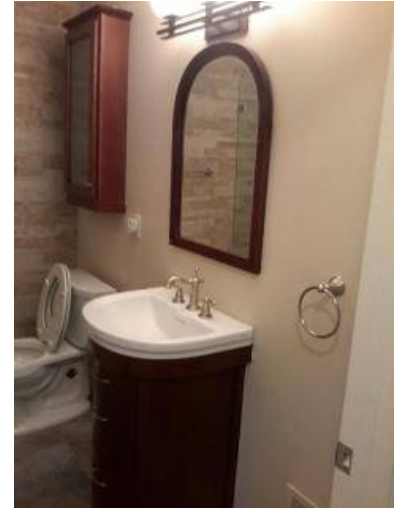
Walls are in good condition with normal wear.

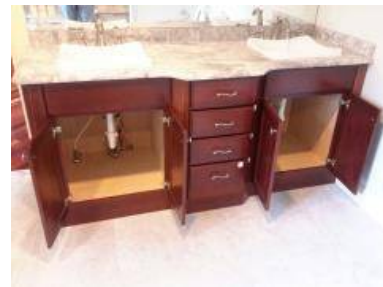
- ☒ ☐ ☐ Functional with no leaks detected, Counters/cabinets appear serviceable.

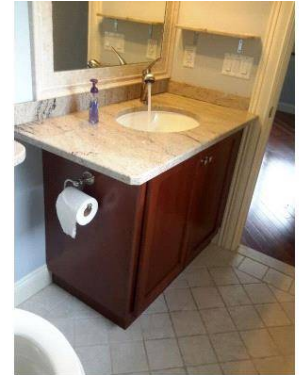
- ☐ ☐ ☒ Functional with no leaks detected, The following problems were noted at the drain: Stopper did not operate properly. Damage is noted at counters/cabinets. Functional with no leaks detected.

Counters/cabinets appear serviceable, Functional with no leaks detected.

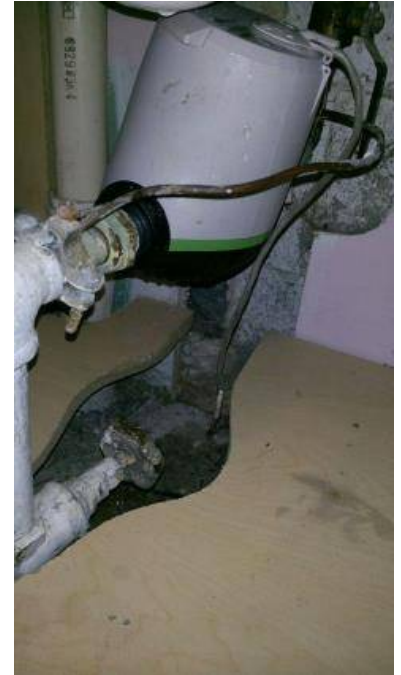
- ☒ ☐ ☐ Water meter is in the lower level bathroom cabinet.

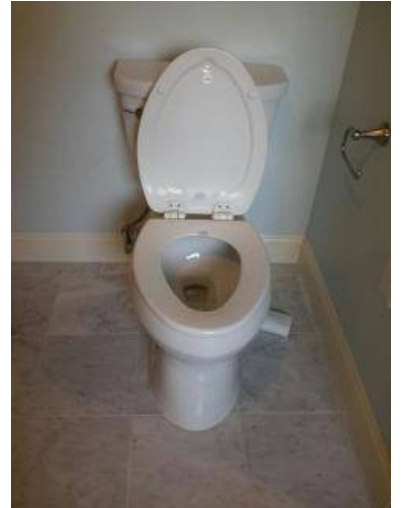
☒ ☐ ☐ Functional with no leaks detected.

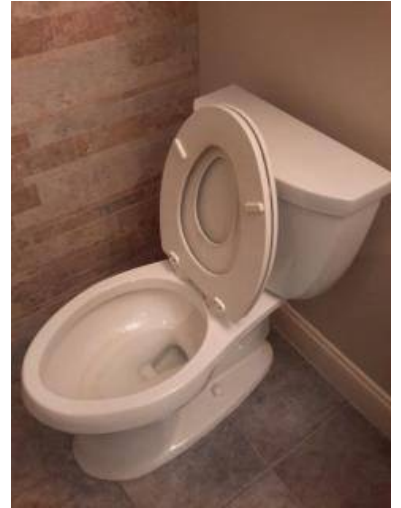
OK MM RR
☒ ☐ ☐ Functional with no leaks detected.

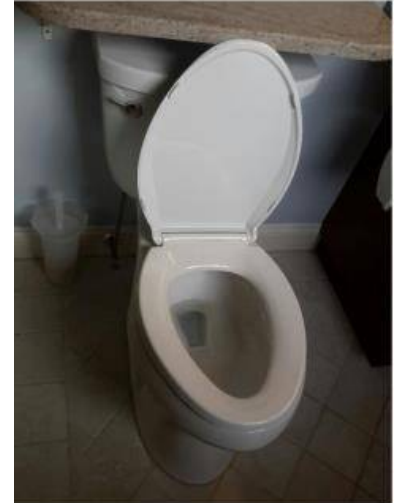
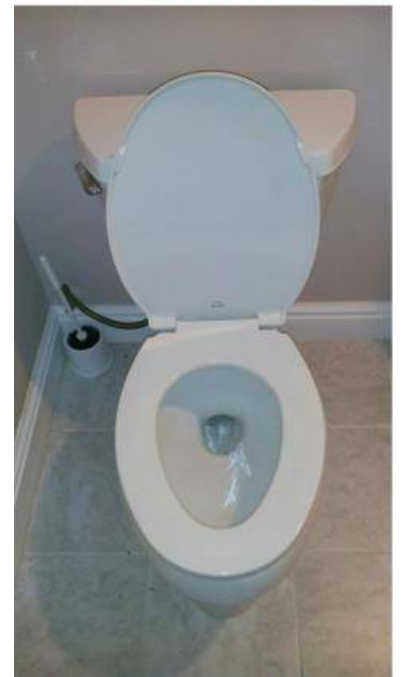
☒ ☐ ☐ Functional with no leaks detected.
Functional with no leaks detected.

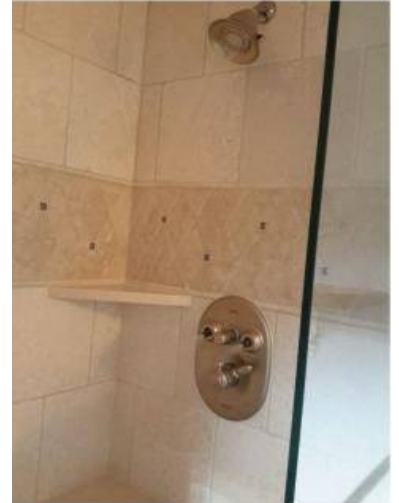
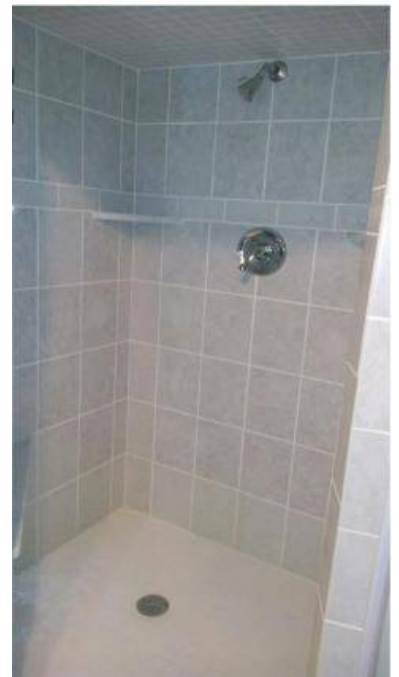
☒ ☐ ☐ Functional with no leaks detected.
Functional with no leaks detected.

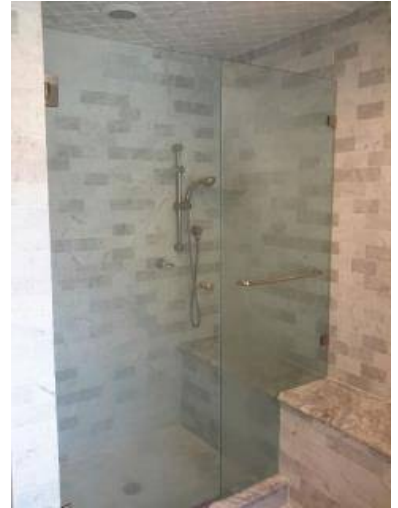
- ☒ ☐ ☐ Ceramic Tile. Shower walls appear serviceable, Enclosure appears serviceable, Caulk and seal all tub and shower areas as a precaution.

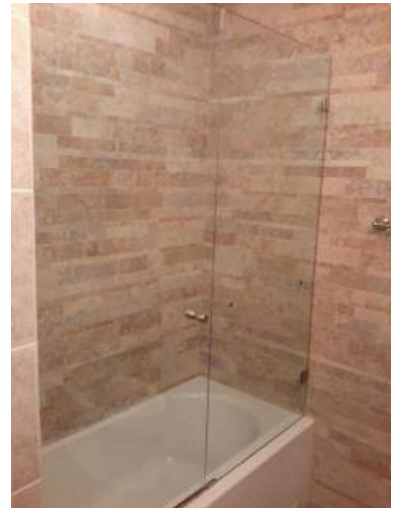
- OK MM RR
☒ ☐ ☐ Ceramic Tile. Shower walls appear serviceable, Enclosure appears serviceable, Caulk and seal all tub and shower areas as a precaution.

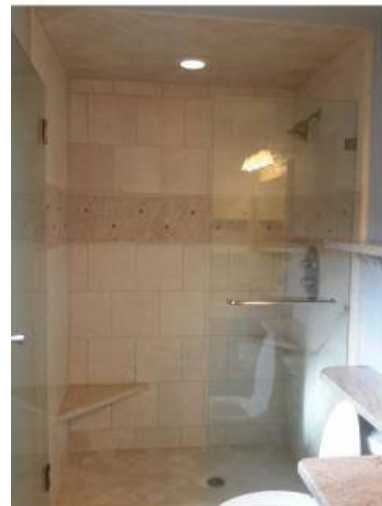
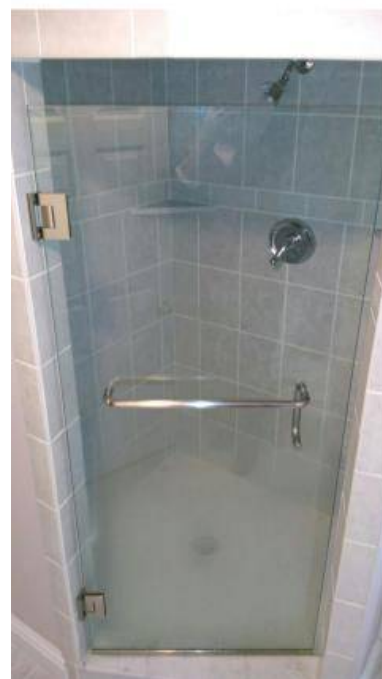
☒ ☐ ☐ Ceramic Tile. Shower walls appear serviceable, Enclosure appears serviceable.

Ceramic Tile. Shower walls appear serviceable, Enclosure appears serviceable, Caulk and seal all tub and shower areas as a precaution.

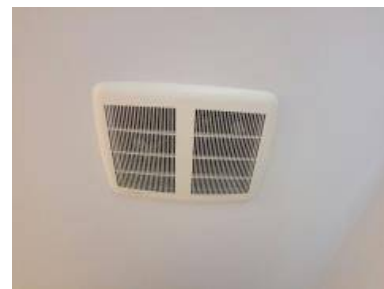
☒ ☐ ☐ Exhaust Fan Functional.

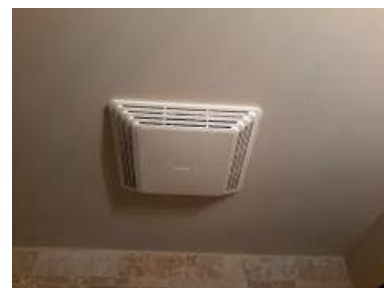
OK MM RR
☒ ☐ ☐ Exhaust Fan Functional.

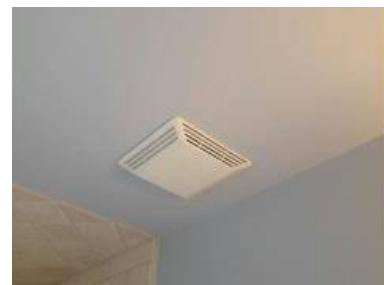
☒ ☐ ☐ Functional.

Exhaust Fan Functional.

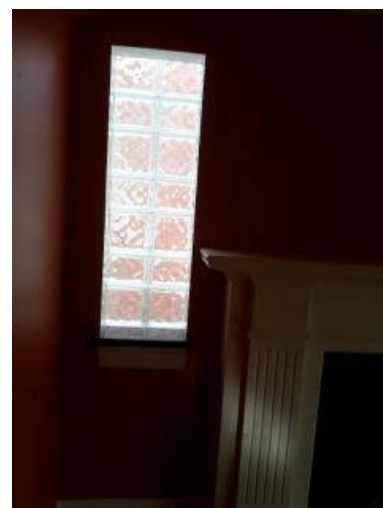
General condition appears serviceable.

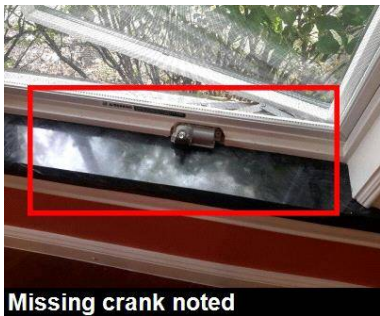
☐ ☒ ☐ Missing hardware.

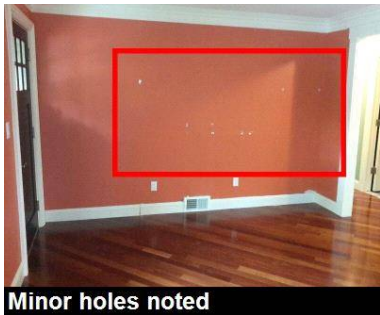
☐ ☒ ☐ General condition appears
serviceable, There is some minor
cracking in the sheetrock. Most
likely this is due to slight settlement
or shrinkage. Damaged noted.

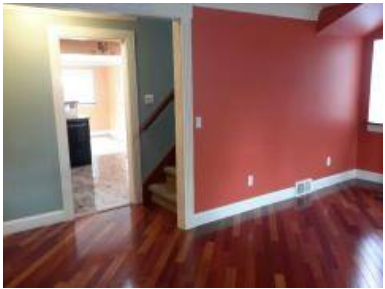
☒ ☐ ☐ General condition appears serviceable, There is some minor cracking in the sheetrock. Most likely this is due to slight settlement or shrinkage.

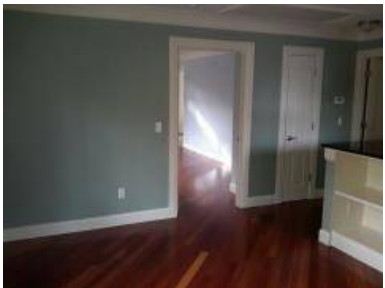
OK MM RR
☒ ☐ ☐ General condition appears serviceable, There is some minor cracking in the sheetrock. Most likely this is due to slight settlement or shrinkage.

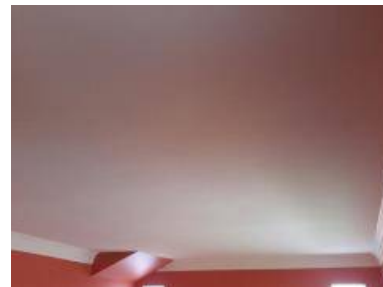
- ☒ ☐ ☐ General condition appears serviceable, There is some minor cracking noted. Be sure to take note of any future movement. Most minor cracking is due to shrinkage of the construction materials.

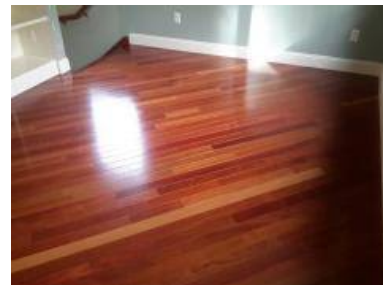
- ☒ ☐ ☐ General condition appears serviceable, The floor covering material is hardwood. Fair - Material is worn, with some age.

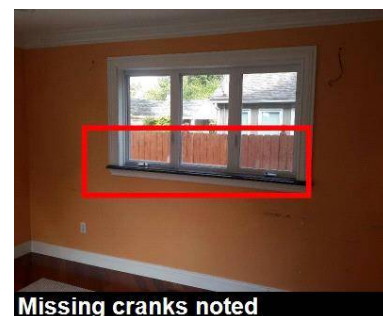
- OK MM RR
☐ ☒ ☐ At least one window or associated hardware in this room needs repair. Locking hardware needs repair or replacement, Cranks missing, can't open windows.

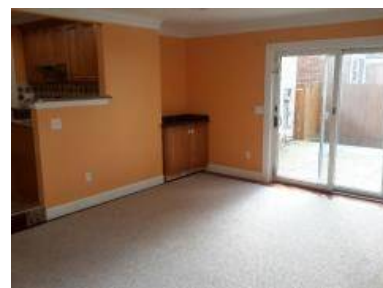
- ☒ ☐ ☐ General condition appears serviceable, There is some minor cracking in the sheetrock. Most likely this is due to slight settlement or shrinkage.

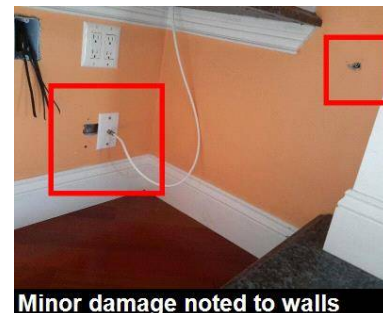
- ☐ ☒ ☐ Damaged noted.

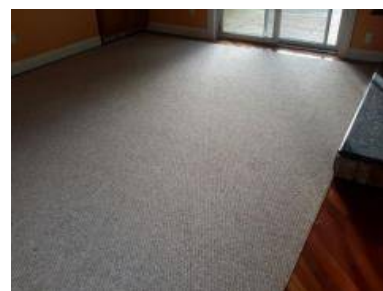
- ☒ ☐ ☐ General condition appears serviceable, The floor covering material is hardwood. Fair - Material is worn, with some age. Visibility and ability to inspect the floor is limited due to the floor covering and/or furnishings.

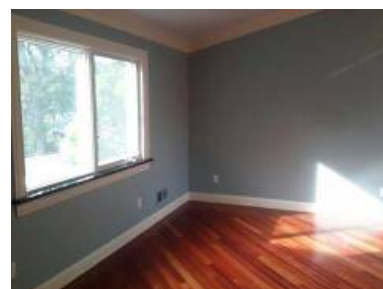
☒ ☐ ☐ General condition appears serviceable, There is some minor cracking in the sheetrock. Most likely this is due to slight settlement or shrinkage.

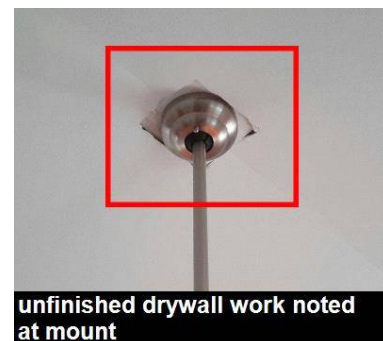
OK MM RR
☐ ☒ ☐ There is some minor cracking noted. Unfinished trim work is noted at fan mount.

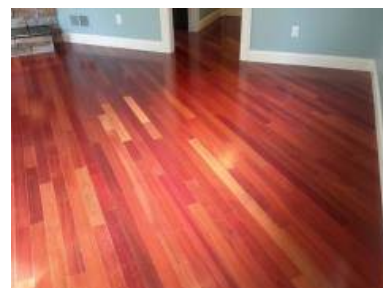
☒ ☐ ☐ General condition appears serviceable, The floor covering material is hardwood. Fair - Material is worn, with some age.

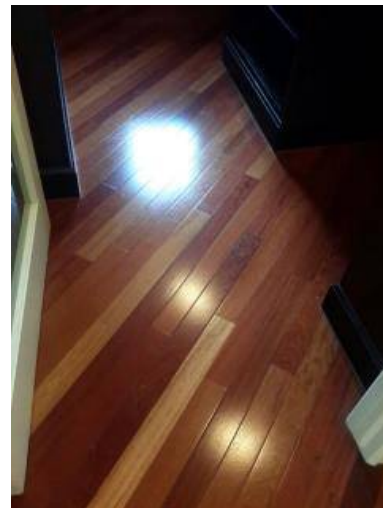
- ☒ ☐ ☐ General condition appears serviceable, The floor covering material is hardwood. Fair - Material is worn, with some age.

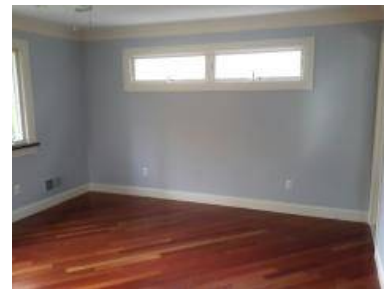
- ☒ ☐ ☐ General condition appears serviceable, There is some minor cracking in the sheetrock. Most likely this is due to slight settlement or shrinkage.

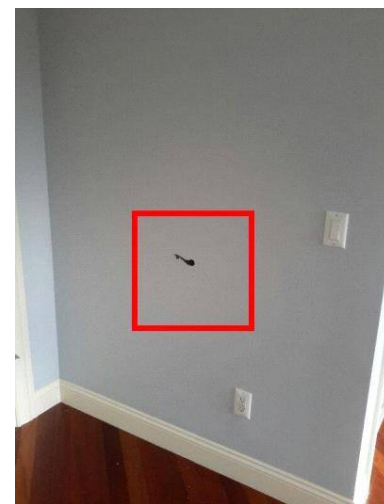
- OK MM RR
☐ ☒ ☐ Hole in the wall from doorknob.

**Damage noted****Floors:**

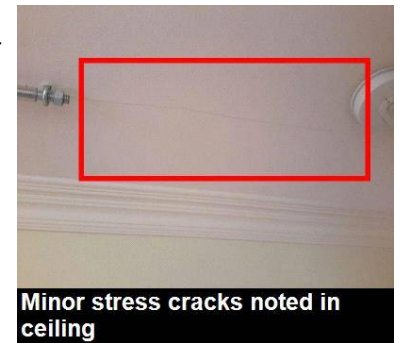
Ceilings:

☐ ☒ ☐ General condition appears serviceable, There is some minor cracking noted.

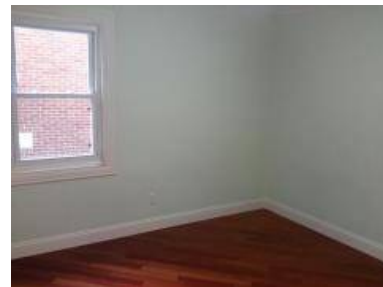
- ☒ ☐ ☐ General condition appears serviceable, There is some minor cracking in the sheetrock. Most likely this is due to slight settlement or shrinkage. Damaged noted.

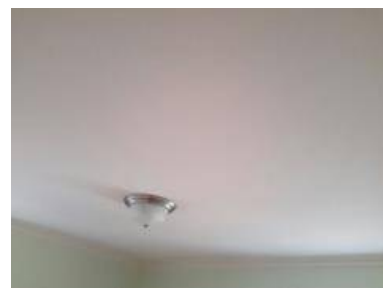
Ceilings:

- OK MM RR
☒ ☐ ☐ General condition appears serviceable, There is some minor cracking noted. Be sure to take note of any future movement. Most minor cracking is due to shrinkage of the construction materials. Damaged noted.

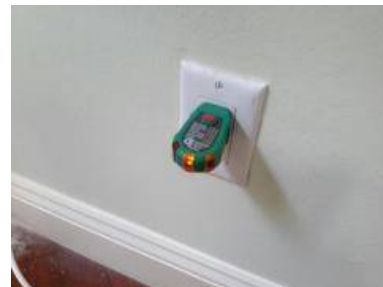
Electrical Outlets:

Some grounded type outlets did not appear to be properly grounded.

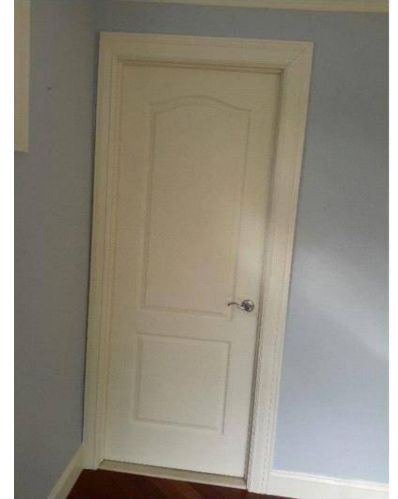
Hardware operational, Door hardware needs adjustment or repair, as the latch or strike plate needs adjustment so that the door will latch correctly.

Adjust knob

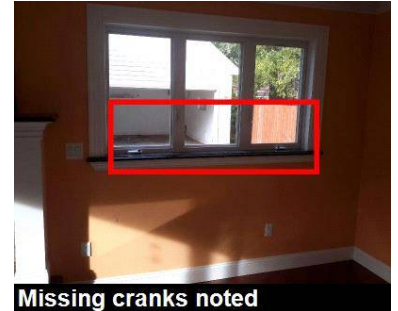
Living Room:

At least one window or associated hardware in this room needs repair. Locking hardware needs repair or replacement, There is no screen in place at the window. Cranks are missing.

Missing cranks noted

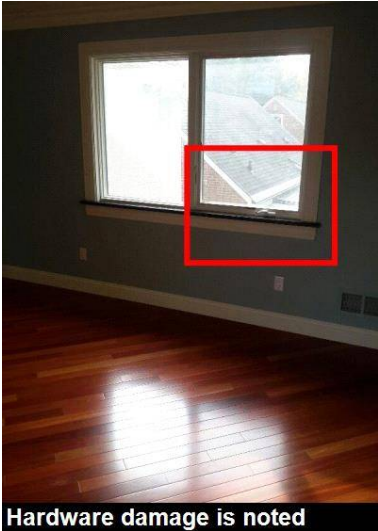
Master Bedroom:

- ☐ ☒ ☐
- At least one window or associated hardware in this room needs repair. Crank for window is broken and won't open the window.

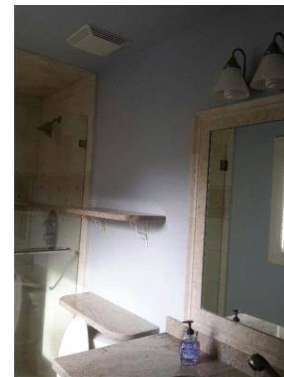
- ☐ ☐ ☒ Hidden Damage - The cracks in the walls may be an indication of hidden structural problems. Further investigation as to the cause is needed. Walls are in good condition with normal wear.

**Hidden mold damage noted***Entry / Foyer / Hall:*

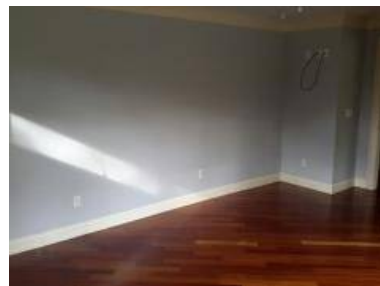
**Bedroom #2:**

- OK MM RR
☒ ☐ ☐ General condition appears serviceable, There is some minor cracking in the sheetrock. Most likely this is due to slight settlement or shrinkage.

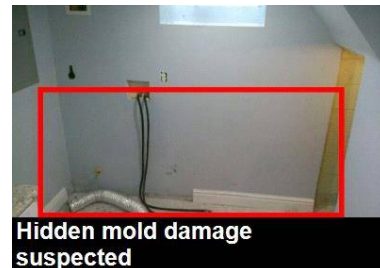
**Laundry:**

- ☐ ☐ ☒ Hidden Damage - The cracks in the walls may be an indication of hidden structural problems. Further investigation as to the cause is needed.

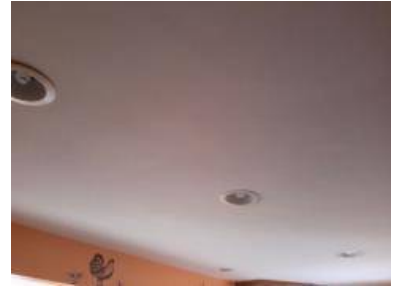
Kitchen Interior:

- ☒ ☐ ☐ General condition appears serviceable, There is some minor cracking noted. Be sure to take note of any future movement. Most minor cracking is due to shrinkage of the construction materials.

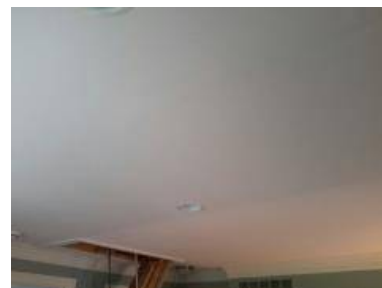
Entry / Foyer / Hall:

General condition appears serviceable, There is some minor cracking noted. Be sure to take note of any future movement. Most minor cracking is due to shrinkage of the construction materials.

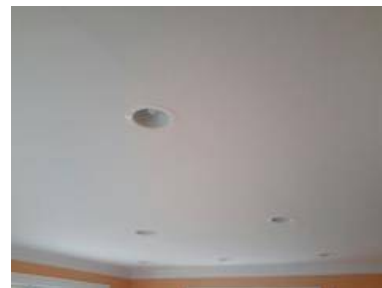
Living Room:

General condition appears serviceable, There is some minor cracking noted. Be sure to take note of any future movement. Most minor cracking is due to shrinkage of the construction materials.

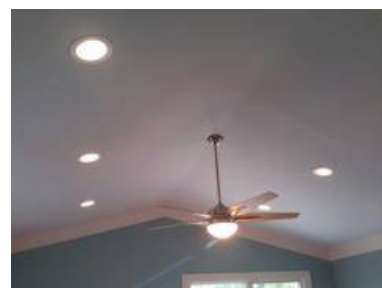
Master Bedroom:

General condition appears serviceable, There is some minor cracking noted. Be sure to take note of any future movement. Most minor cracking is due to shrinkage of the construction materials.

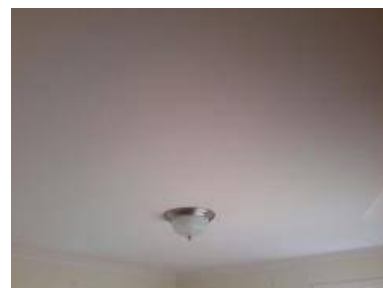
Bedroom #3:

OK MM RR
☒ ☐ ☐ General condition appears serviceable, There is some minor cracking noted. Be sure to take note of any future movement. Most minor cracking is due to shrinkage of the construction materials.

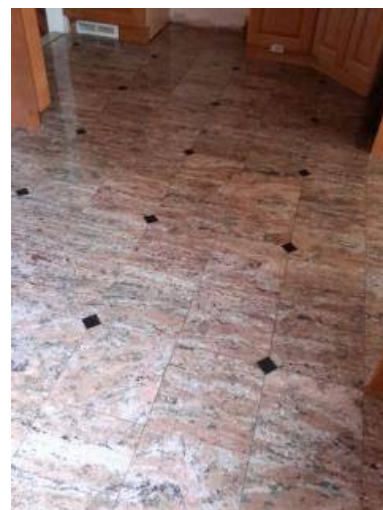
Kitchen Interior:

☒ ☐ ☐ General condition appears serviceable, The floor covering material is glazed ceramic tile. Fair - Material is worn, with some age.

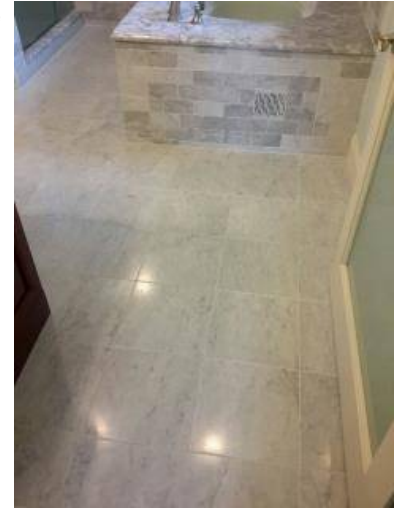
Master Bath:

The floor covering material is Glazed ceramic tile
Fair - Material is worn, with some age.

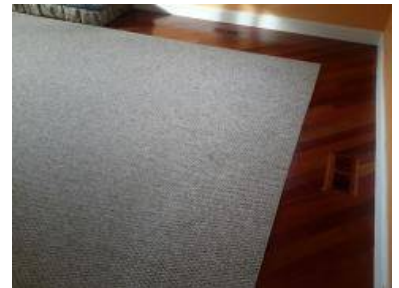
Living Room:

OK MM RR
☒ ☐ ☐ General condition appears serviceable, The floor covering material is hardwood. Fair - Material is worn, with some age. Visibility and ability to inspect the floor is limited due to the floor covering and/or furnishings.

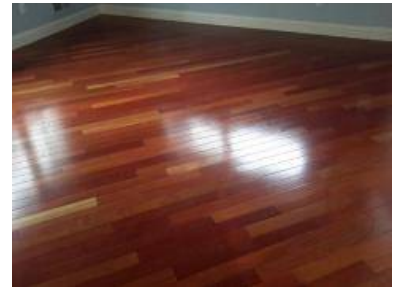
Bedroom #2:

☒ ☐ ☐ General condition appears serviceable, The floor covering material is hardwood. Fair - Material is worn, with some age.

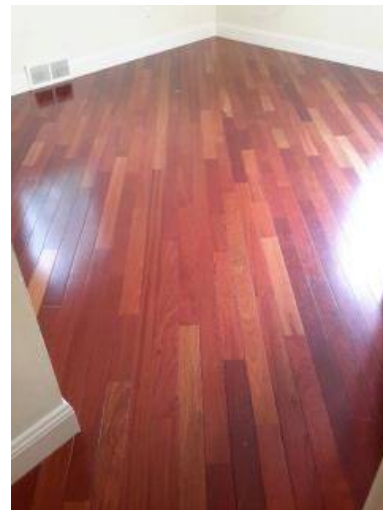
Bedroom #3:

- ☒ ☐ ☐ General condition appears serviceable, The floor covering material is hardwood. Fair - Material is worn, with some age.

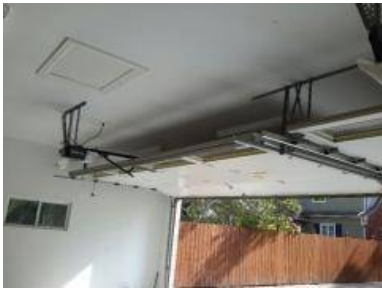
☒ ☐ ☐ Metal.

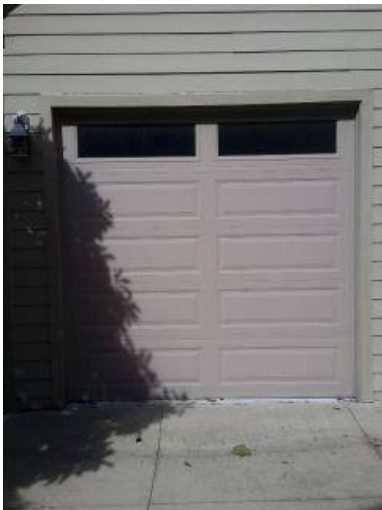
OK MM RR
☒ ☐ ☐ Metal.

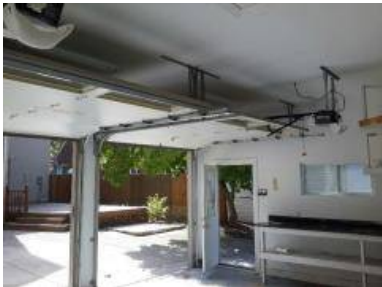
☒ ☐ ☐ Metal.

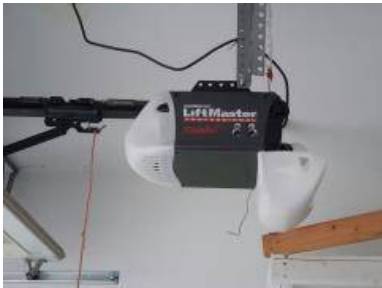
Automatic Opener:

☒ ☐ ☐ operational, Automatic reverse
feature is operational.

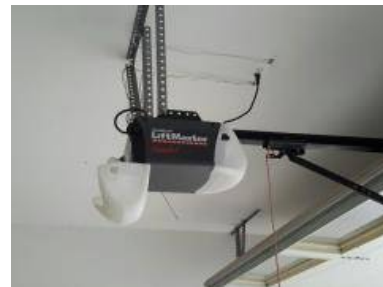
☒ ☐ ☐ operational, Automatic reverse feature is operational.

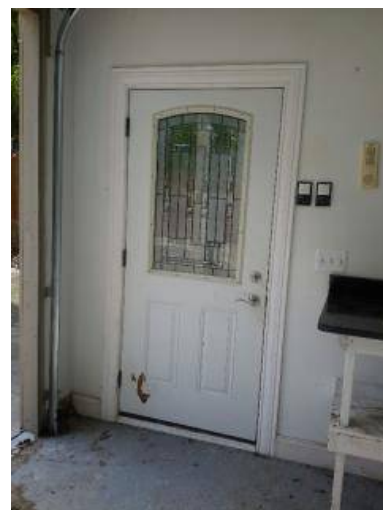
Service Doors:

OK MM RR
☒ ☐ ☐ General condition appears serviceable.

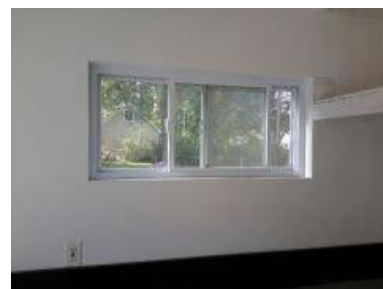
☒ ☐ ☐ General condition appears serviceable.

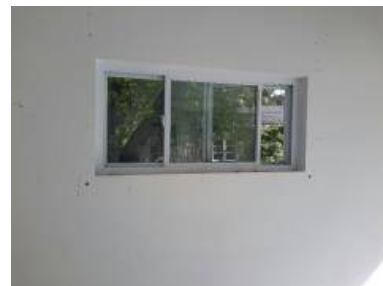
☒ ☐ ☐ General condition appears serviceable.

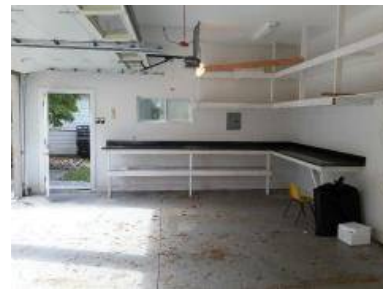
- ☒ ☐ ☐ Drywall, General condition appears serviceable, Typical cracks noted.

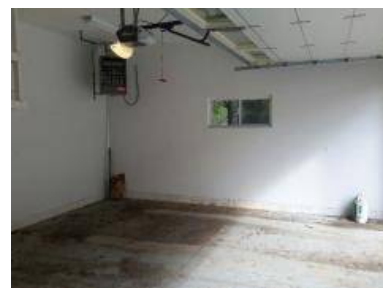
- OK MM RR
☒ ☐ ☐ Drywall, General condition appears serviceable, Damage noted, Typical cracks noted.
