Visual Pro Home Inspections
6239 Eastmoor Road
Bloomfield Hills MI 48301
248-688-7918
vincentcameron@VisualProHomeInspections.com

Confidential Inspection Report

2325
Birmingham, MI 48009

October 10, 2014

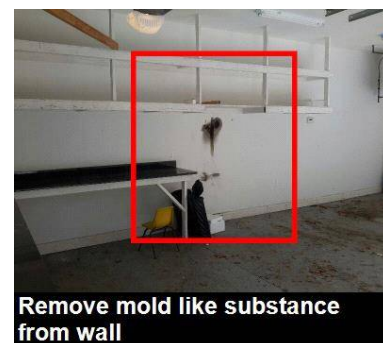
- ☐ ☒ ☐ Drywall, General condition appears serviceable, Damage noted, Typical cracks noted.

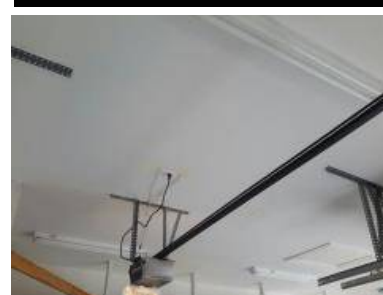
- Drywall, General condition appears serviceable, Minor Damage noted.

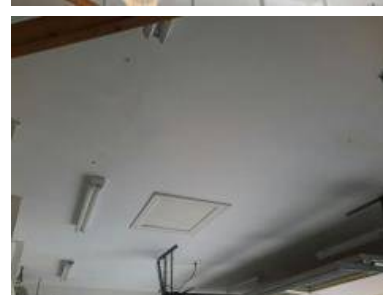
- Drywall, General condition appears serviceable, Minor Damage noted.

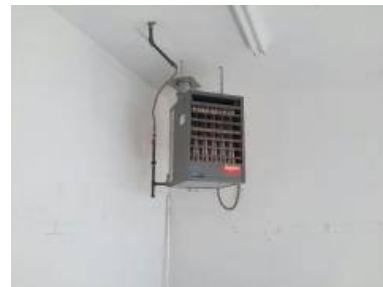
Furnace Did not function. it appears the thermostat may need new batteries.

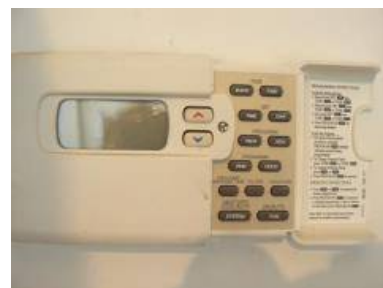
☐ ☐ ☒ It appears the thermostat may need new batteries.

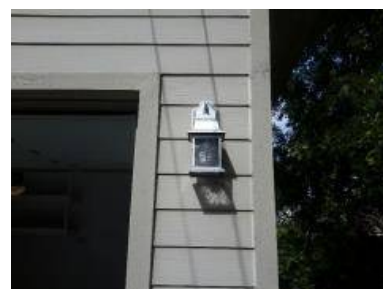
Switches & Fixtures:

The light installed in this room did not function using the wall switch. I did not determine if the switch is bad or if the light bulb is bad.

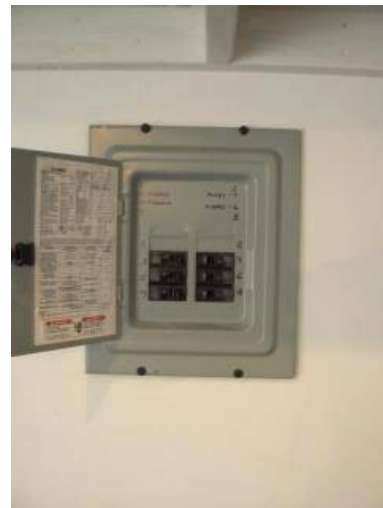
Sub panel is functional and operating as intended.

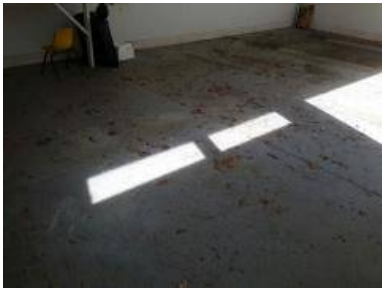
☒ ☐ ☐ General condition appears
serviceable, Salt damage is noted.

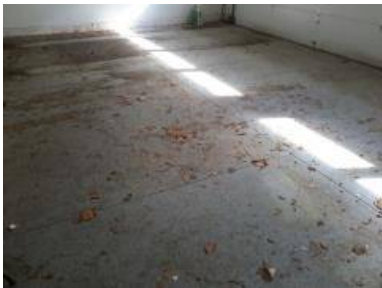
OK MM RR
☒ ☐ ☐ General condition appears
serviceable, Salt damage is noted.
